Good Stuff

ISSUE NO. 2

This Newsletter is meant as an information document. It's contents are not necessarily Company Policy. It's a means by which LCG Product Support can distribute some tidbits of information to you.

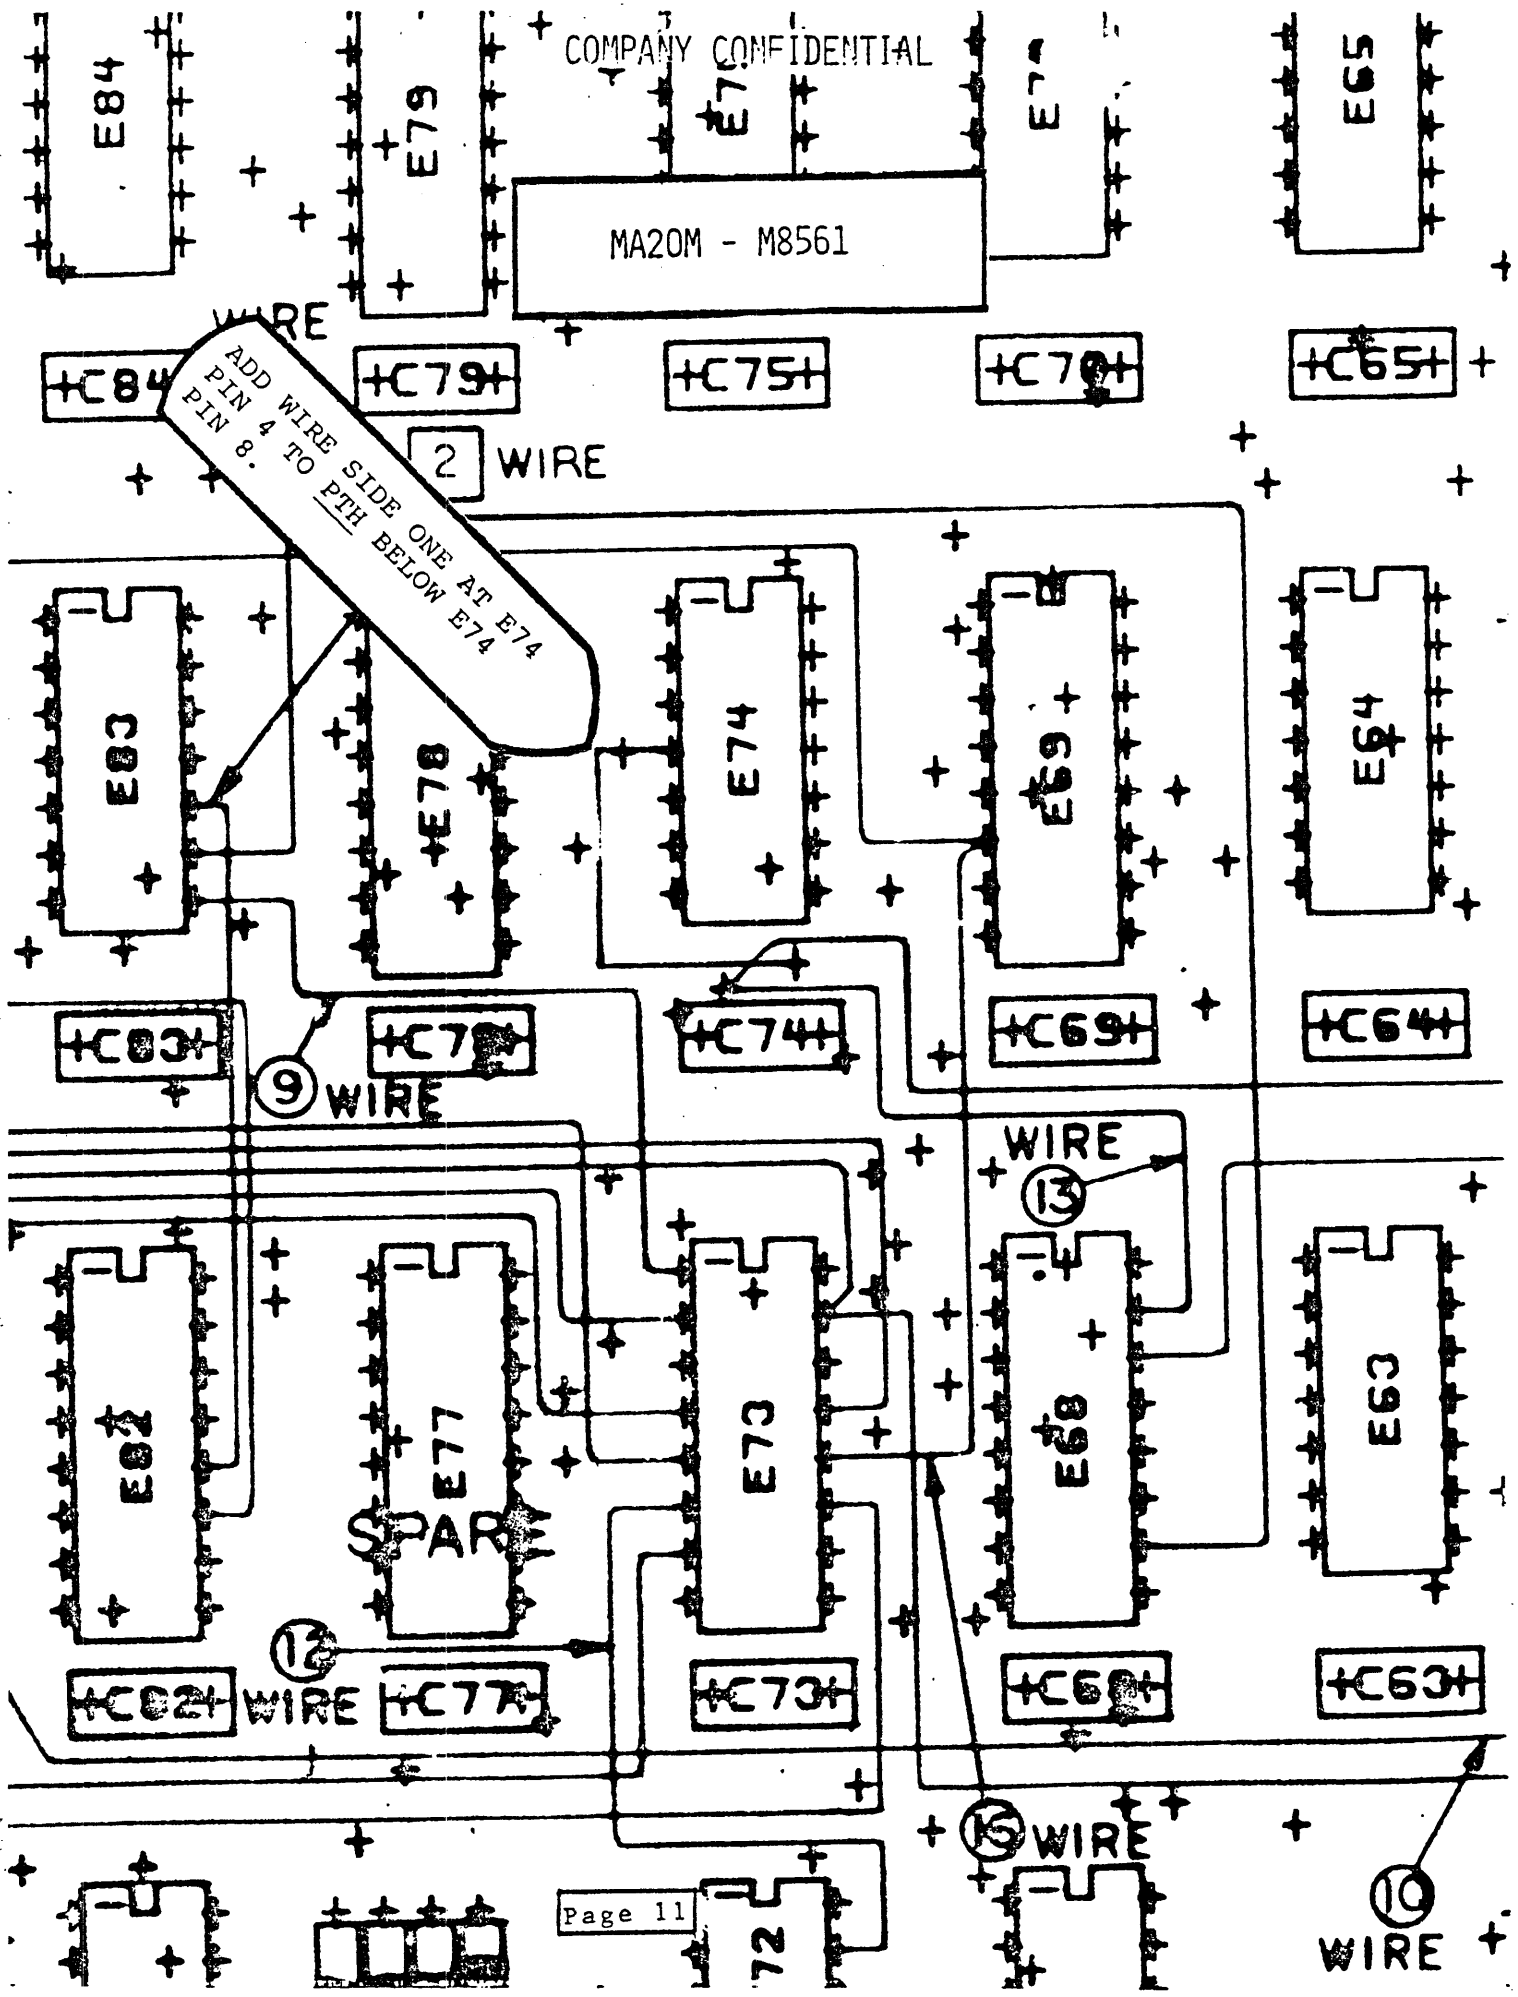
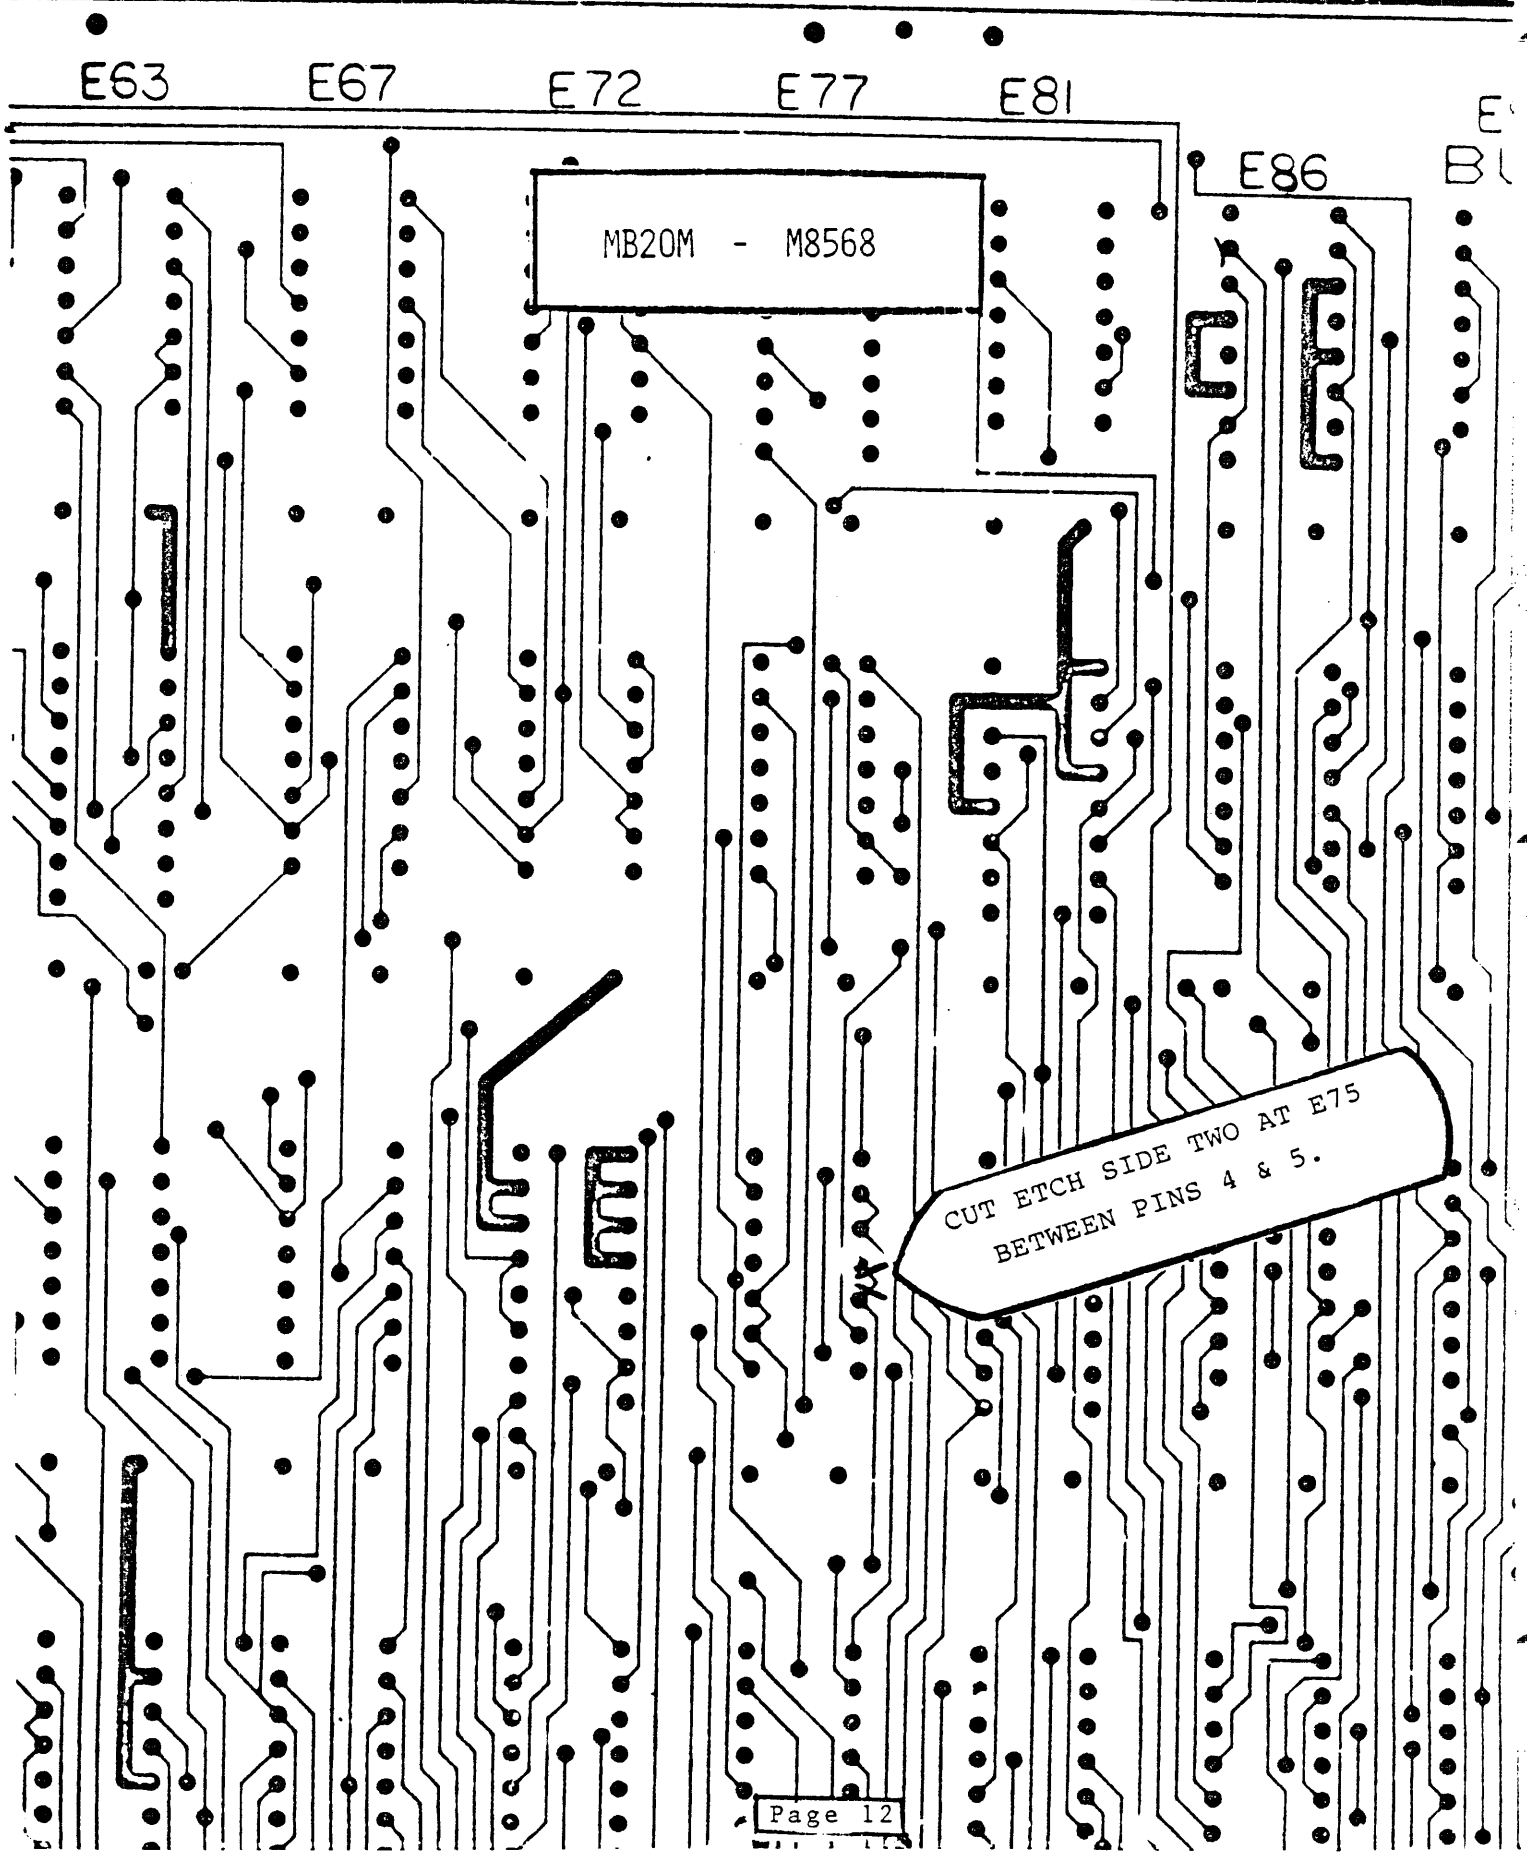
MA20M - M8561

ADD WIRE SIDE ONE AT E74
PIN 4 TO PTH BELOW E74

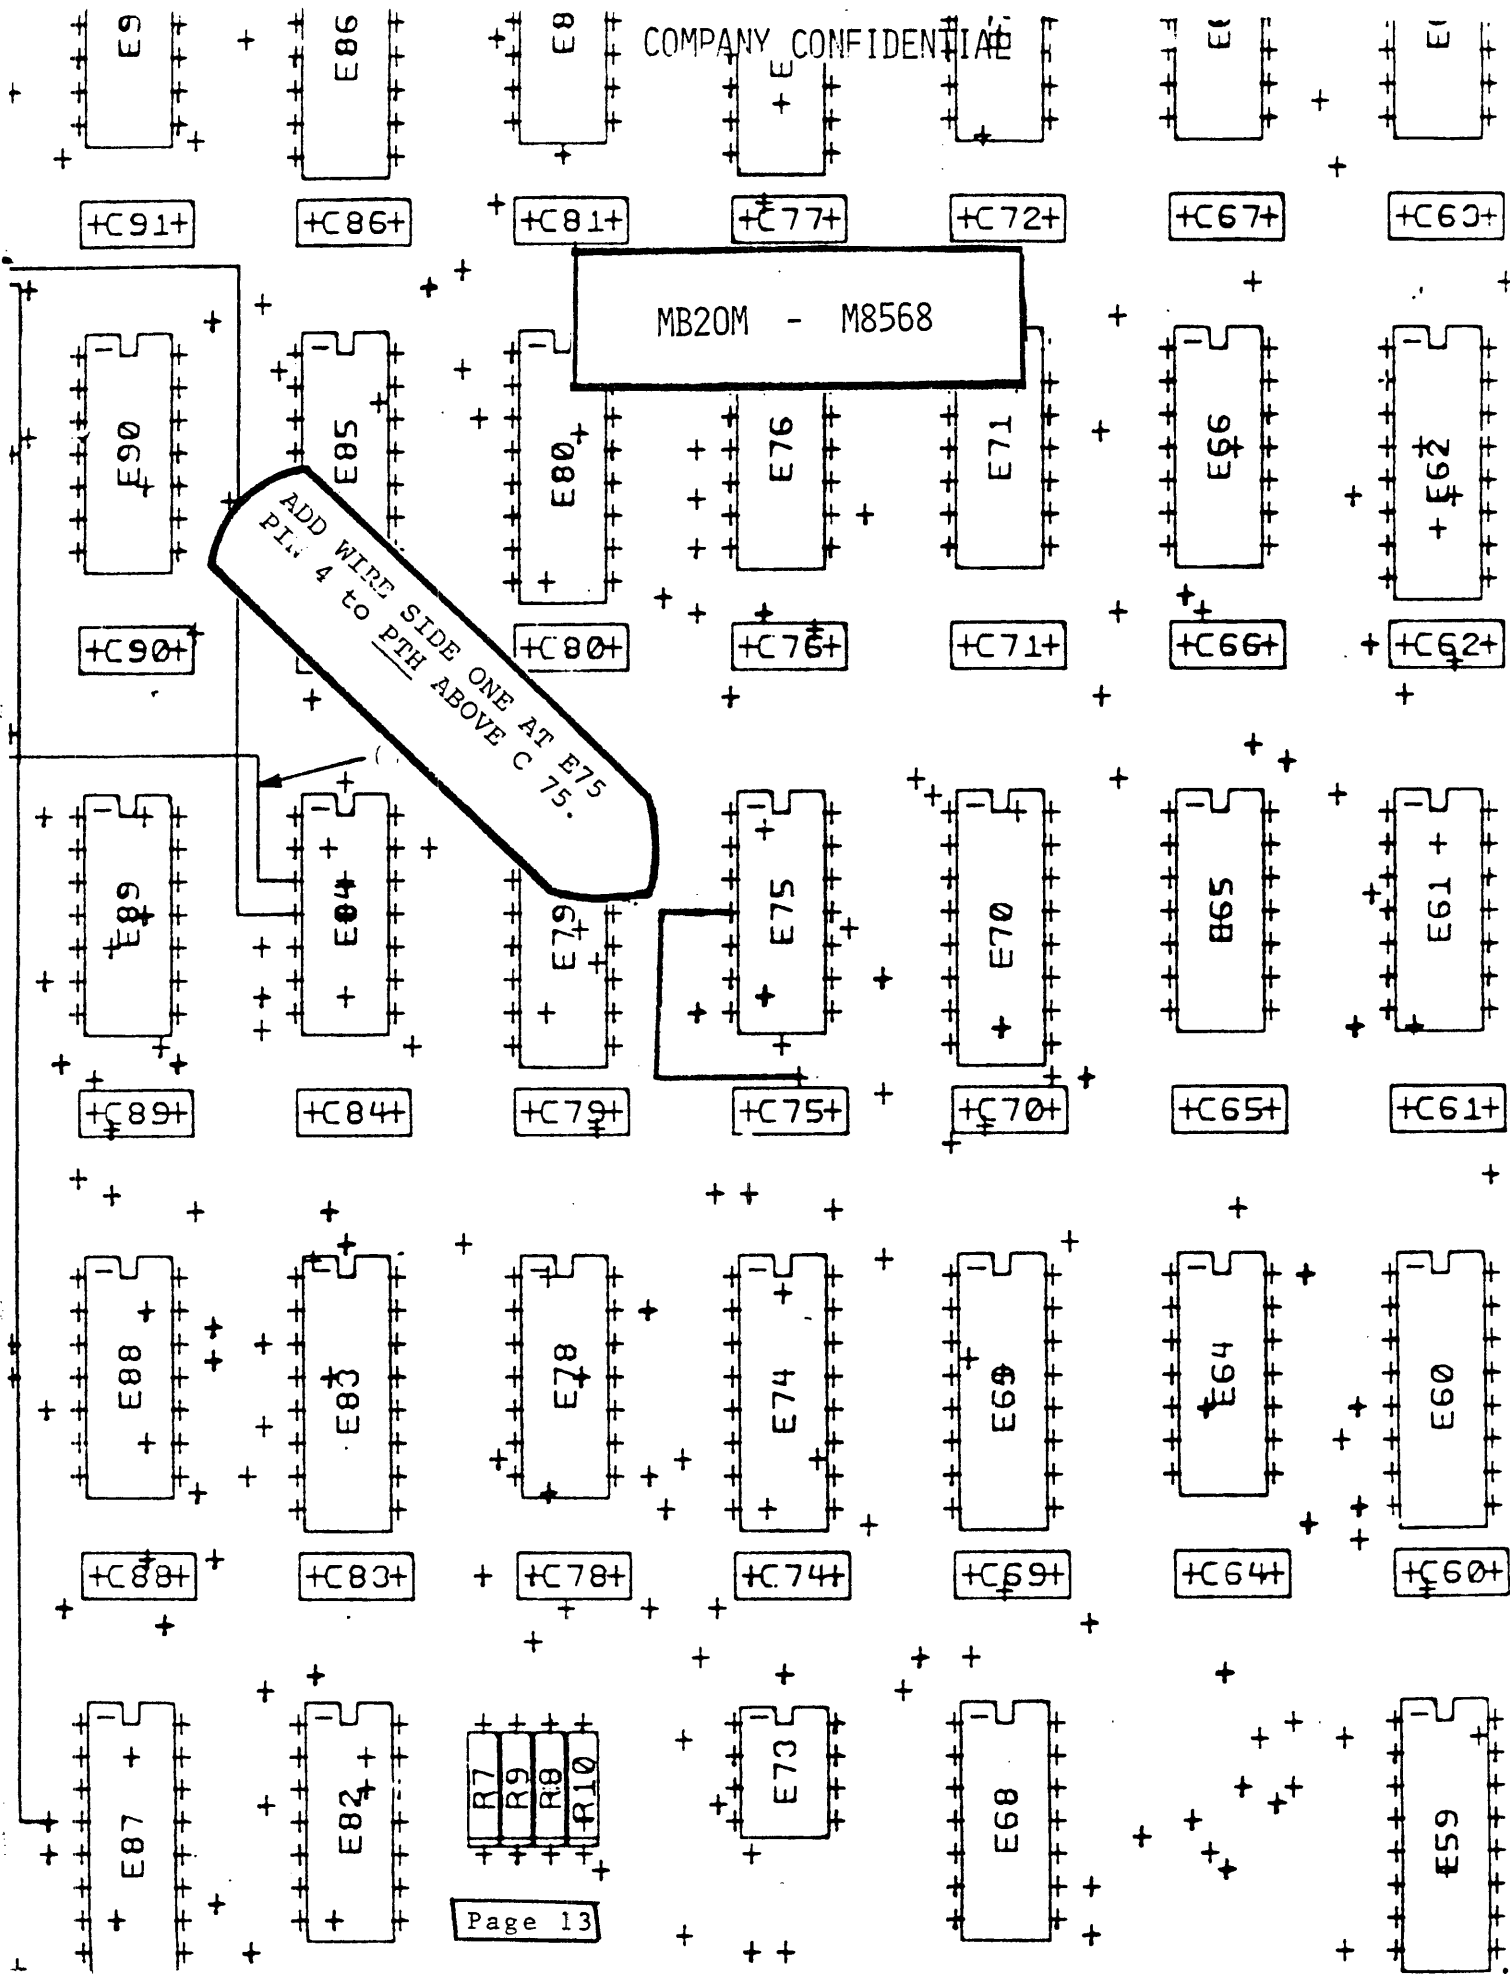
MB20M - M8568

ADD WIRE SIDE ONE AT E75
PIN 4 TO PTH ABOVE C 75.

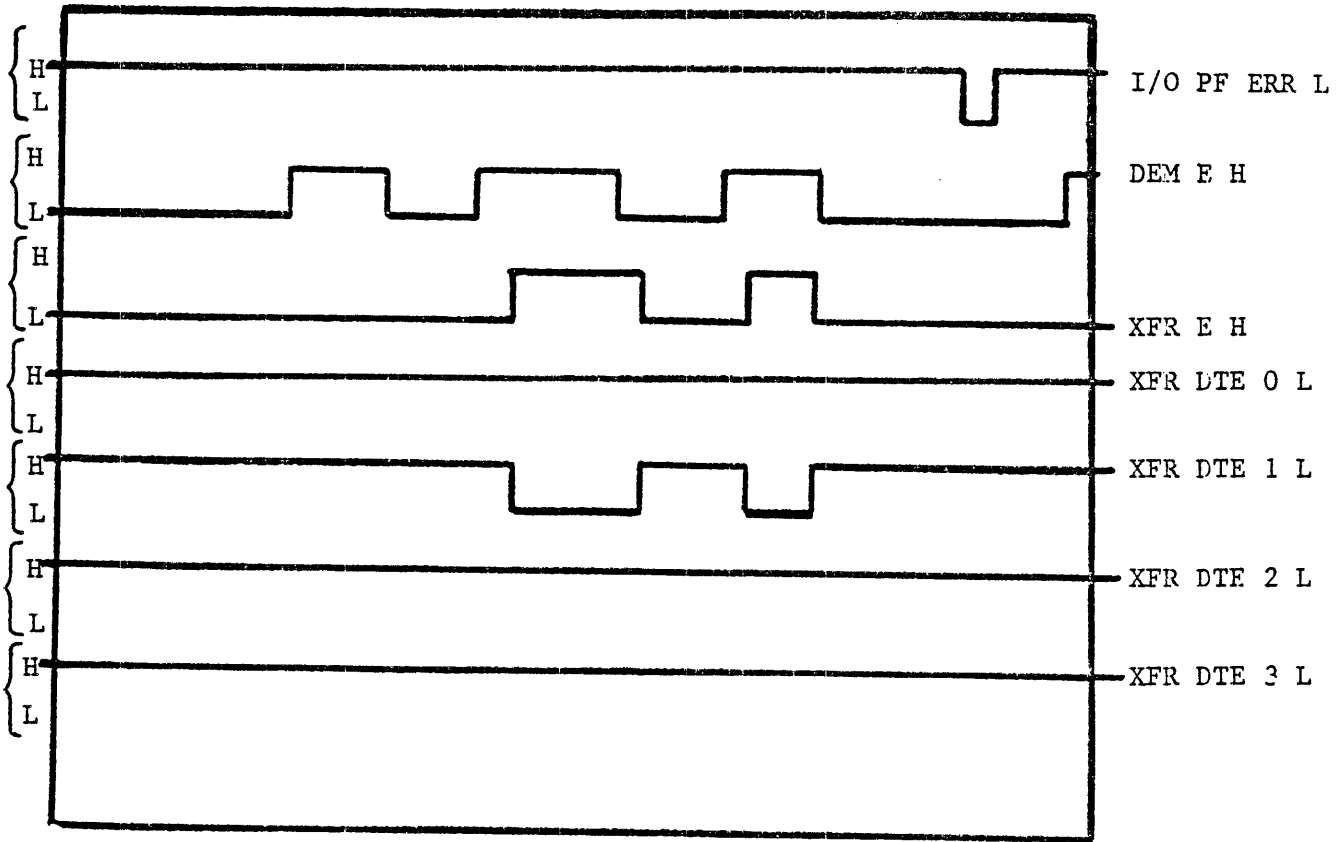
I/O PAGE FAIL CAUSED BY DTE #1

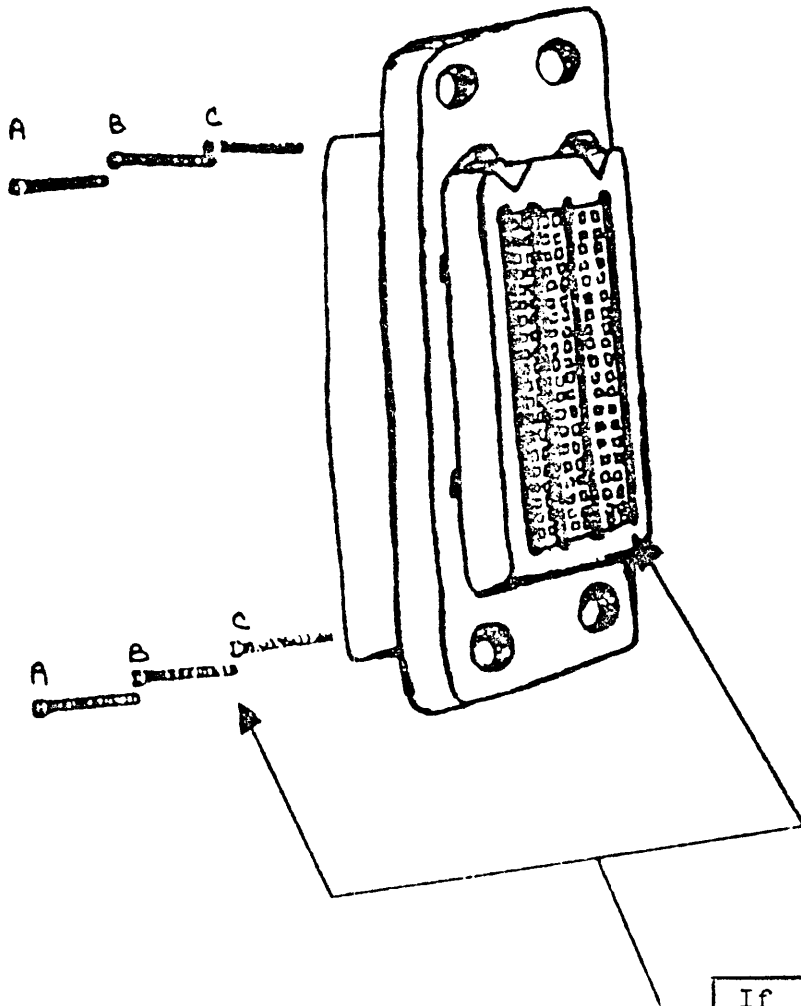
A problem has been found in the RH20 Massbuss Connectors in the KL10. The six screws on the male side of the connector must be fully tightened. If they are not tightened down properly, the female pins of the connector will not be flush with the connector block, causing improper pin connection. The six screwheads can be seen from the pin side of the RH20 backplane.

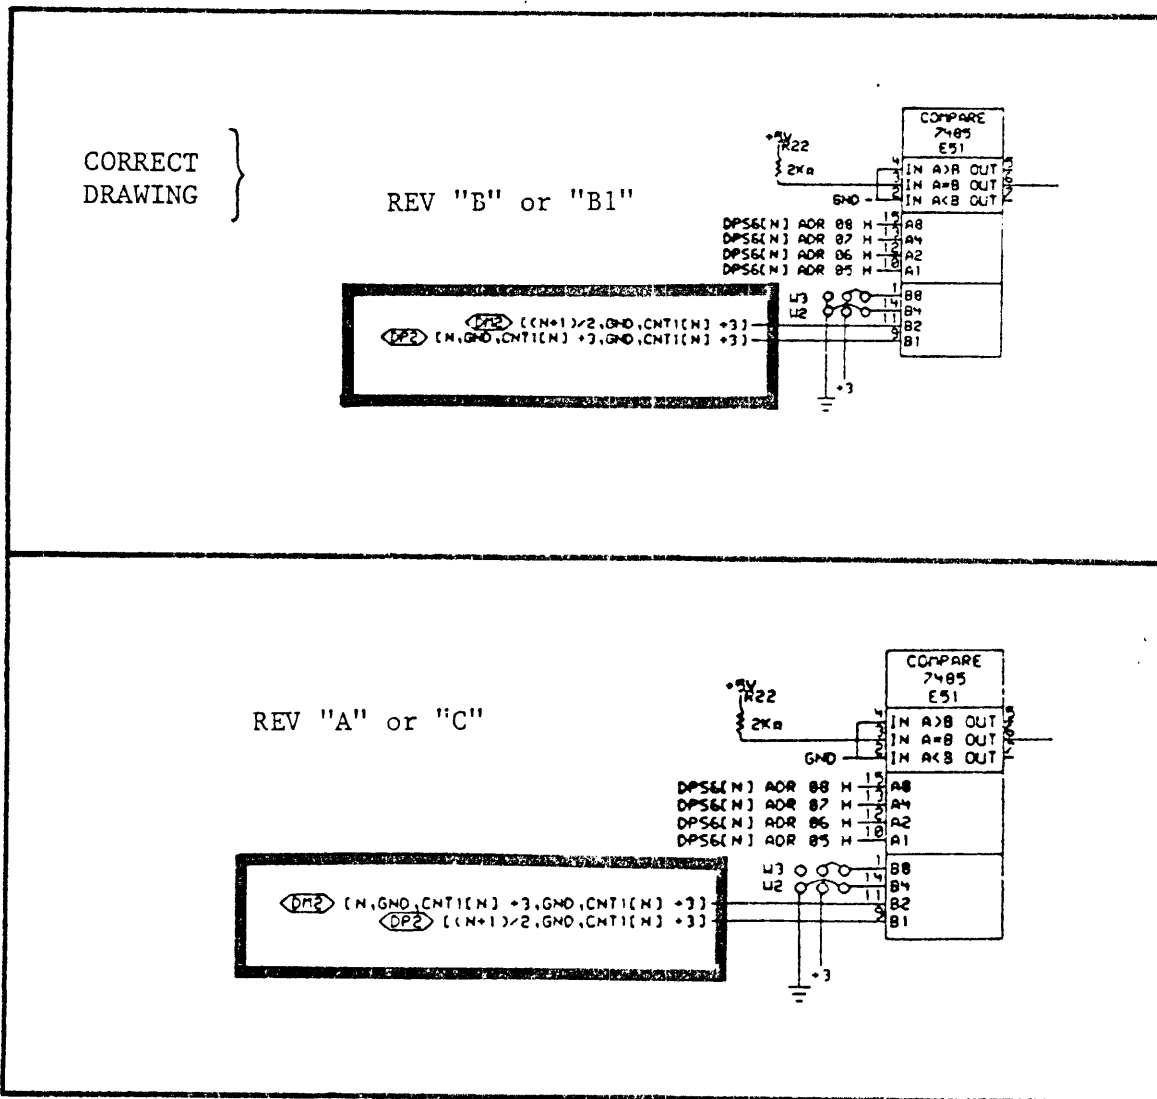
KL10 PRINT M8552-0-DPS1

An error exists in the KL10 print set for the DTE20. The error is on print M8552-0-DPS1 for Revision "A" or "C" drawings. The Revision "B" or "B1" drawing is correct. The signals on pins DP2 and DM2 should be reversed on the Revision "A" and "C" drawings.
