Operation

TEAPOT

Project 5.4

EVALUATION OF FIREBALL LETHALITY
USING BASIC MISSILE STRUCTURES (C)

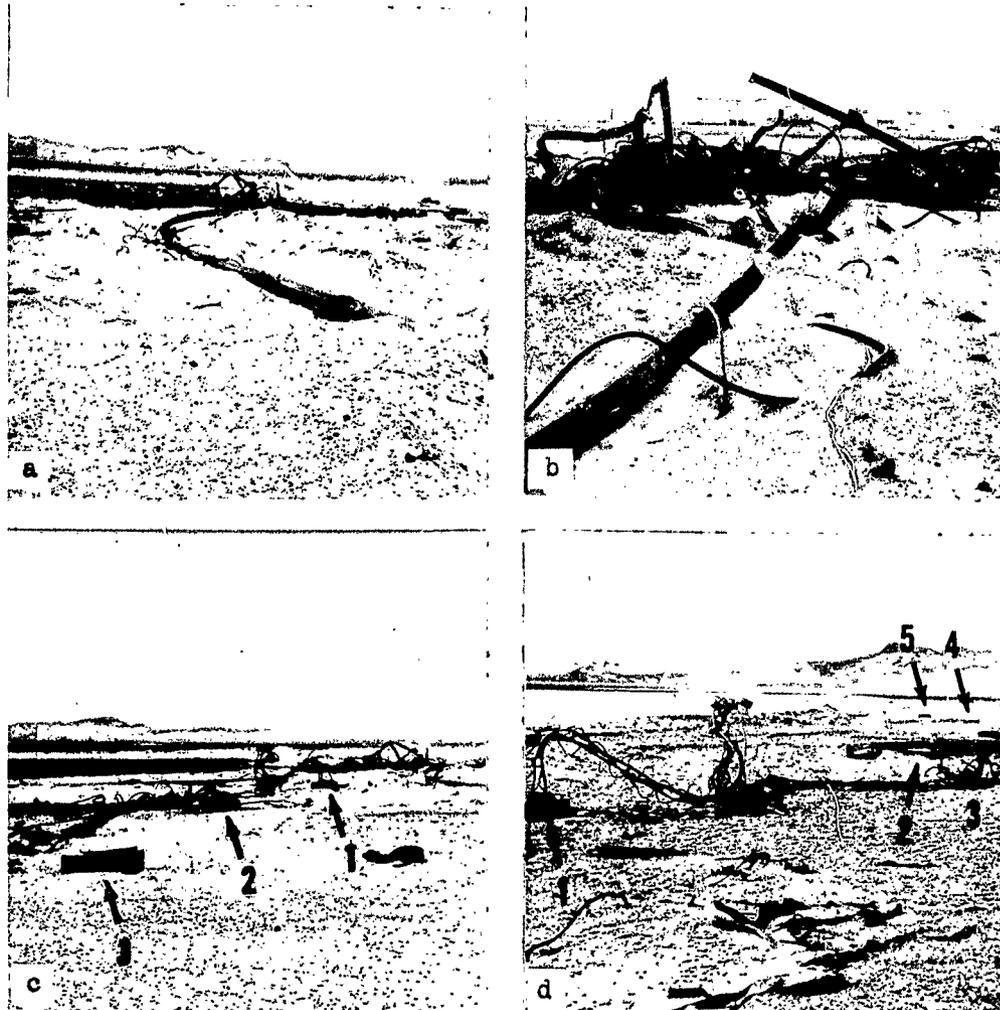
No portion of the shot tower or the five specimen towers was left standing; however, nearly 225 feet of the main support members of the shot tower were still intact and layed out radially from their original position. About 150 feet of both Tower 1 and Tower 2, though in a twisted, almost unrecognizable form, were still intact and attached to their bases. General pictures of the debris near ground zero are given in Figure 3.1. Approximately 100 feet of twisted television tower, believed to be from Tower 3, was still intact and found about 70 feet behind its base. For the most part, however, what remained of the towers was found at ranges beyond 800 feet with isolated pieces at ranges of over 2,000 feet. Further information on damage to the shot tower and to other shot towers used during Operation Teapot is given in Appendix C.

Figure 3.1 General Debris of Shot Tower and TV Towers. (a) General
View of Shot Tower Werckage. (b) Close-up View of Shot Tower Wreckage
(c) Debris r..ar TV Tower Bases 1, 2, and 3, Looking Toward G.Z.
(d) TV Tower Wrekage Looking away from G.Z. Note Five TV Tower Bases.

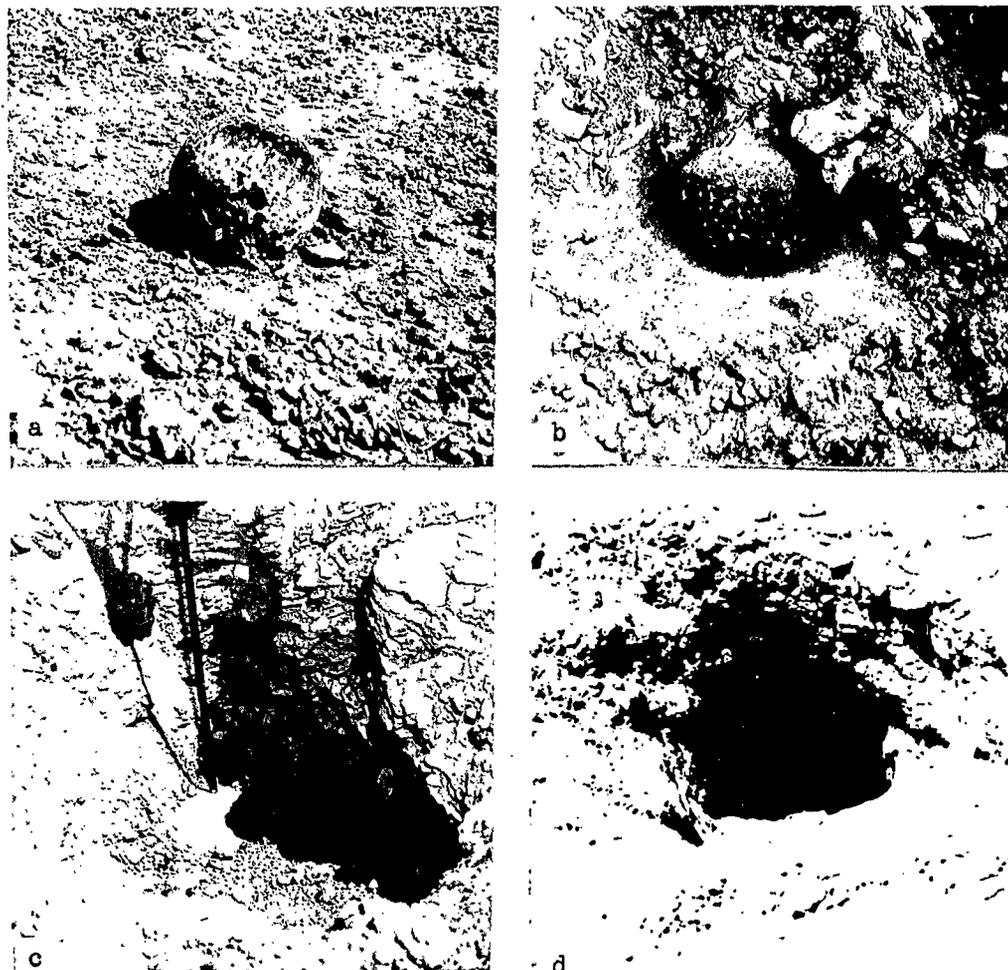
What appeared to be fuzed silica was splattered over the upper surface of partly buried specimens and the specimens which were found above ground, as can be seen in Figure 3.2 (a) and (b). The aluminum sphere from Tower 2 (Figure 3.2a) was the most-heavily coated. This material came off easily with brushing and washing. There was apparently only a

Figure 3.2 Typical Post-Shot locations of Test Specimens. (a) Solid Aluminum Sphere, Tower 2, found above ground. (b) Solid Aluminum Sphere, Tower 5 , found semi-buried. (c) Solid Steel Sphere, Tower 4, found buried approximately 30 in. deep. (d) Solid Steel, Tower 1, found buried approximately 37 in. deep.

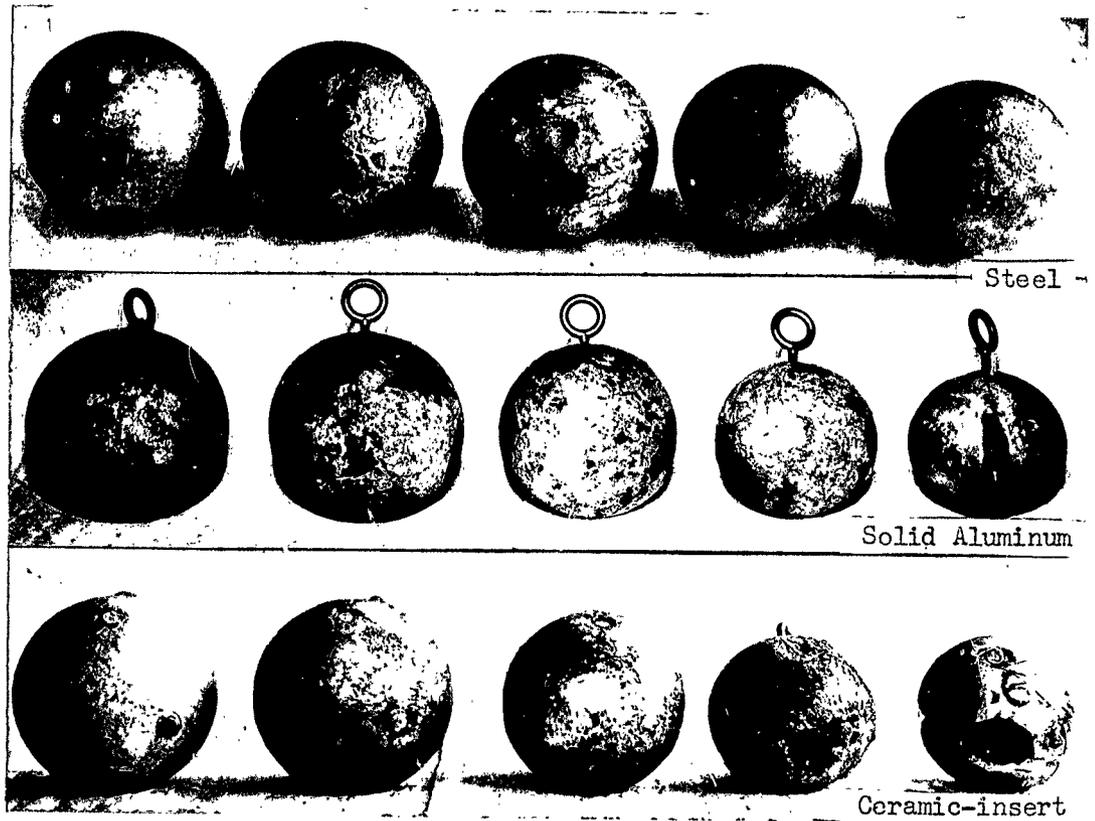
Figure 3.4 Overall Views of Each
Type of Spherical Specimen Showing
Gradation in Size. Left to Right,
Towers 5, 4, 3, 2, 1.

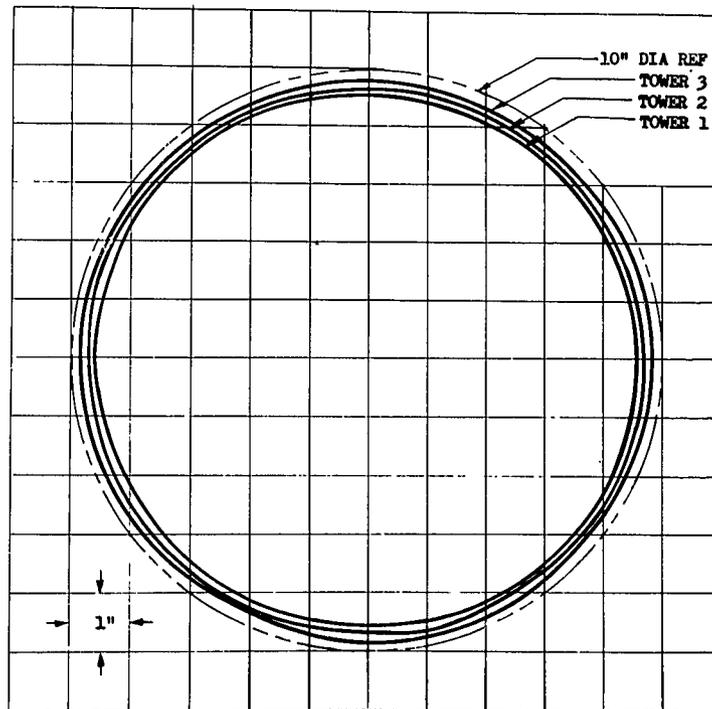
Figure 3.5 Profiles of Steel Spheres

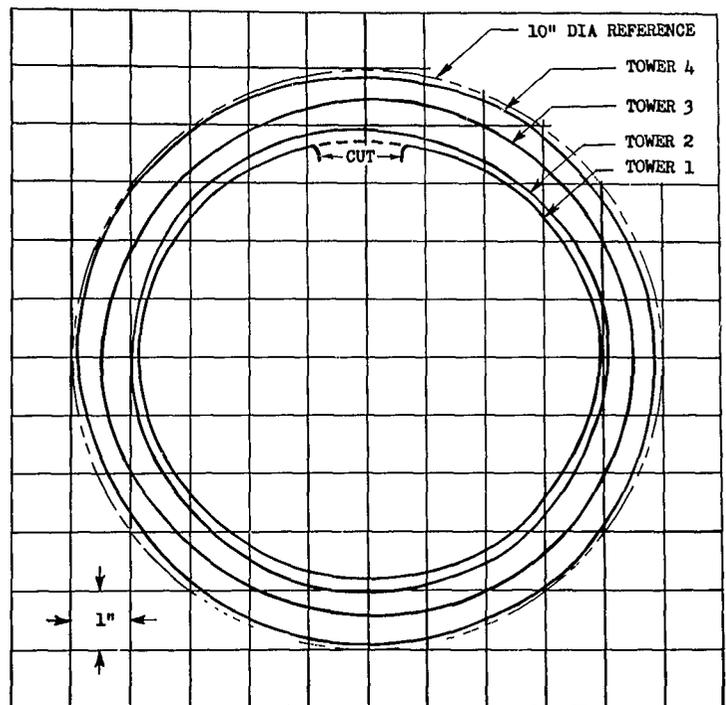
Figure 3.6 Profiles of
Solid Aluminum Spheres

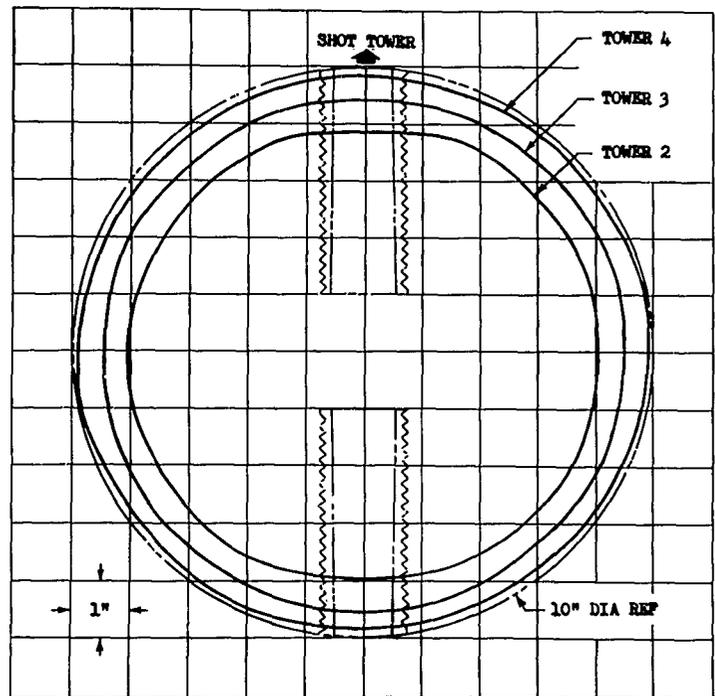
ceramic-insert spheres from the Towers 2 and 3; however, this is probably
a local effect caused by the proximity of the ceramic inserts. The front
and rear Armour ceramic inserts were positioned approximately in the
horizontal plane, as indicated in Figure 3.7.

Figure 3.7 Profiles of
Ceramic-Insert Spheres

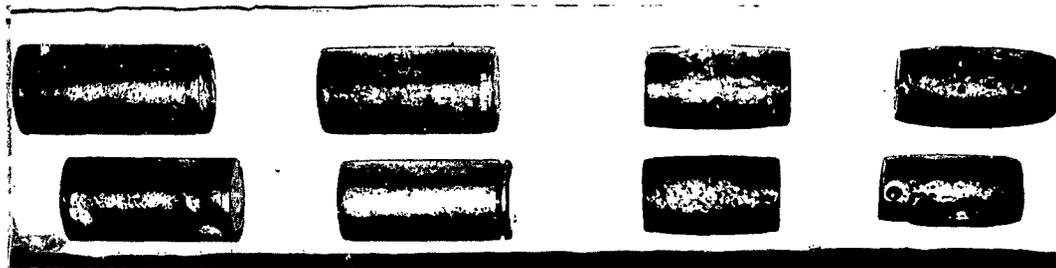
observed. A group photograph of the cylinders is shown in Figure 3.8.
The metal loss was noticeably nonuniform along the length of the cylinder,
there being considerably more metal loss near the ends than at the center,
giving a barrel shaped appearance. This barreling was pronounced at the
two closest ranges, was measurable at Tower 3, but practically nil at
the fourth tower, where there was little metal loss. Longitudinal cross

Figure 3.8 Overall View of Steel Cylinders. Left to Right, Towers 1, 2, 3, 4.

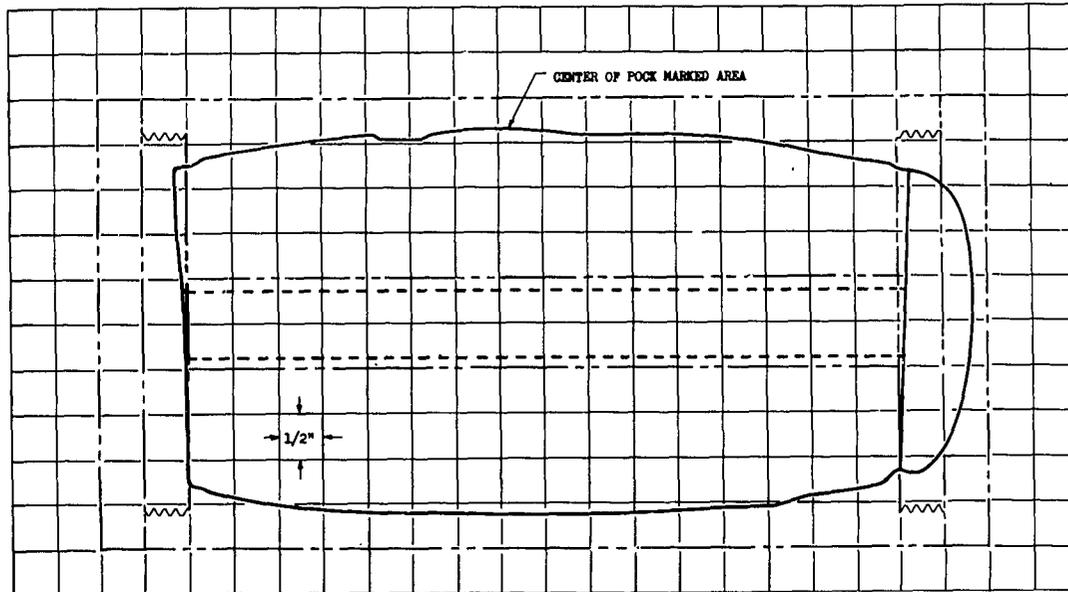
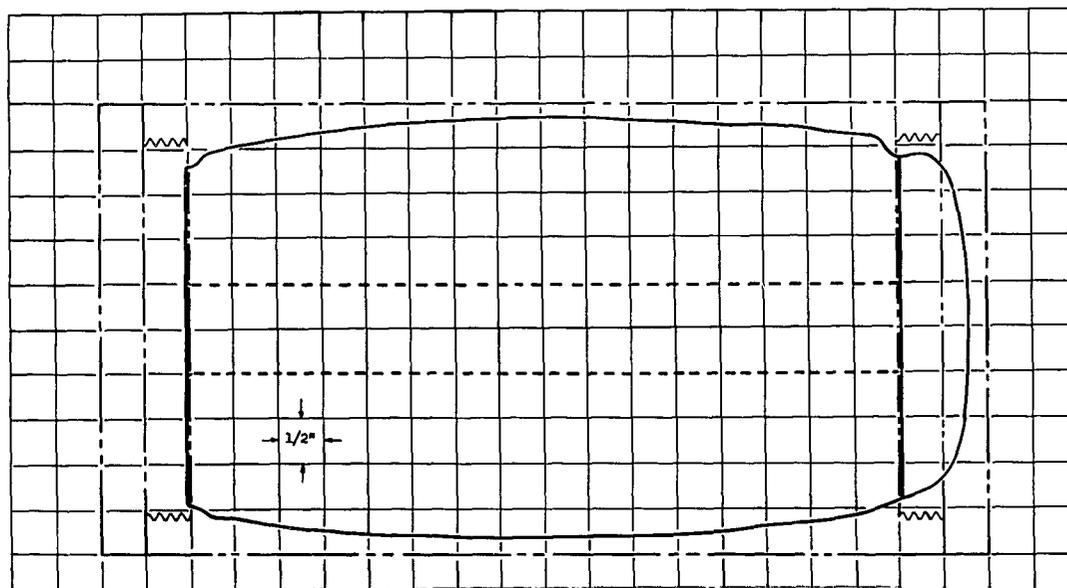
There were large indentations or pock marks on the surface of the cylinders from Towers 1 and 2. Some of these indentations measured about 7/16 in. deep by 1 3/8 in. in diameter at the first tower and at the second tower about 7/32 in. deep by 1/2 in. diameter. There were pock marks on the cylinders from Tower 3, though lesser in number and magnitude. No pock marks were noted on the specimens from Tower 4. Photographs of two of the more-severely indented cylinders are presented in Figure 3.13. In general, the pock marks occurred only in small areas. The largest area was on the cylinder on the left side of Tower 1 (Figure 3.13a) and was extremely irregular over nearly the entire half of the cylinder. The sides opposite the pock-mark areas were relatively smooth.

(a) Profile in Plane of Minor Axis of Elliptical Cross-section. Center of Pock-Mark Area is at Top of Profile.

Figure 3.9   Longitudinal Profiles of Cylinder From Right Side of Tower 1

(b) Profile in Plane of Major Axis of Elliptical Cross-section. This Profile is at 90° to Profile (a) Above.

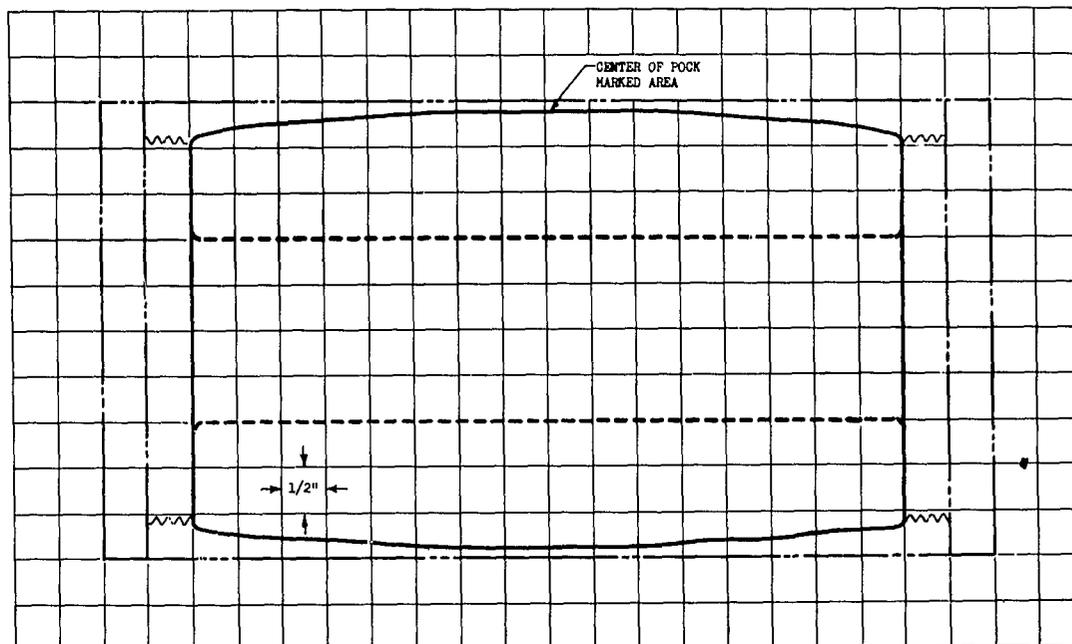
Figure 3.10 Longitudinal Profile of Cylinder From Right Side of
Tower 2.   Center of pock-mark area is at top of page.

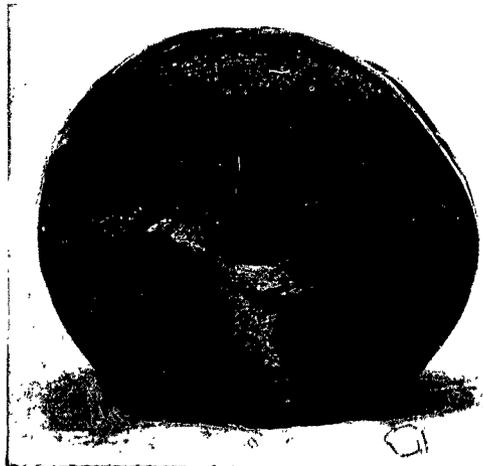
Figure 3.12 End Face of Cylinder
From Left Side of Tower 1. Note
elliptical cross-section and molten
metal flow on face

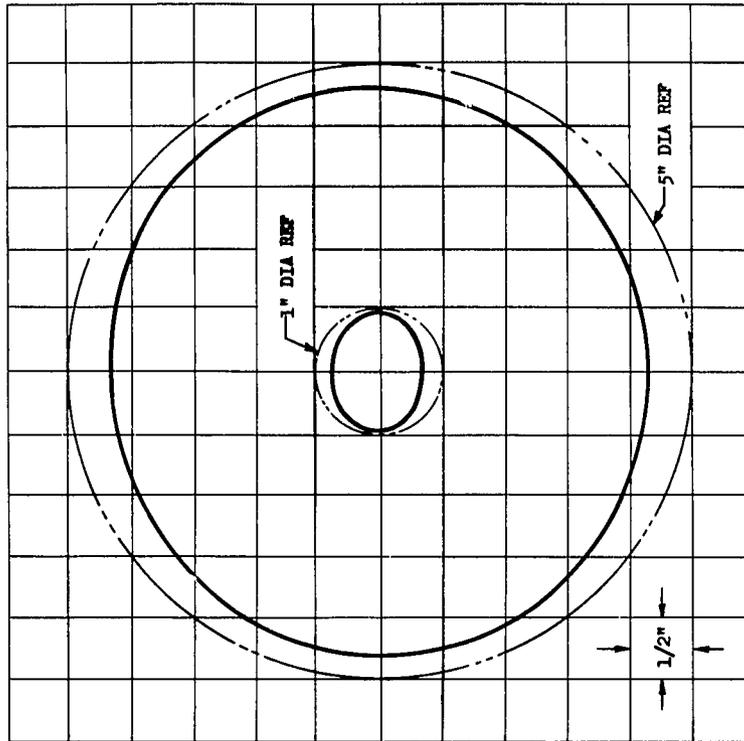
Figure 3.15 Cross Section at Center of Cylinder From Right Side of Tower 1

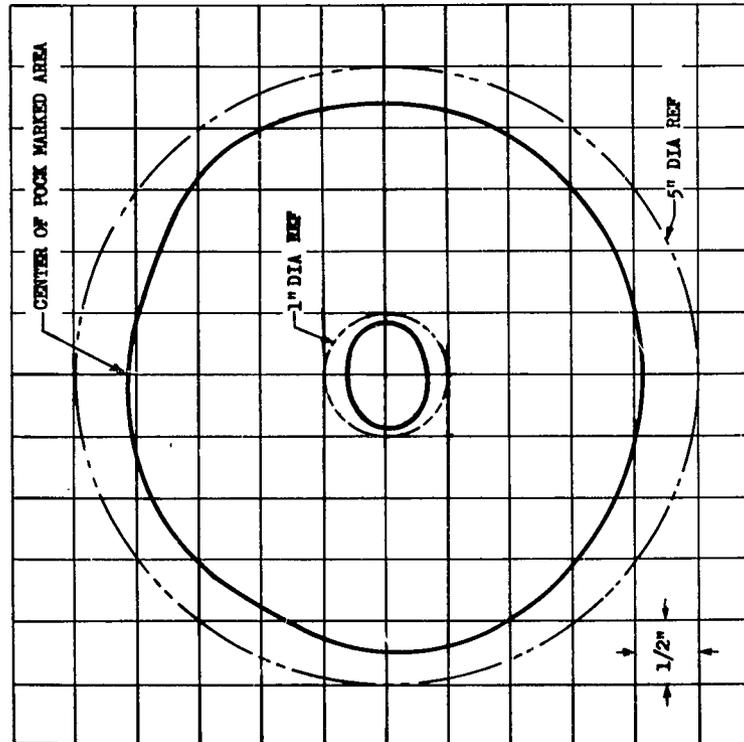
Figure 3.14 Cross Section at Center of Cylinder From Left Side of Tower 1

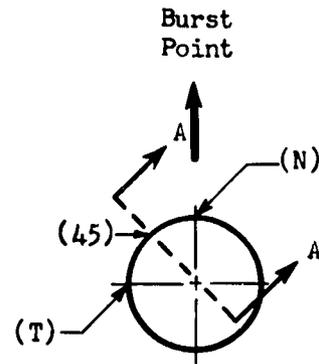
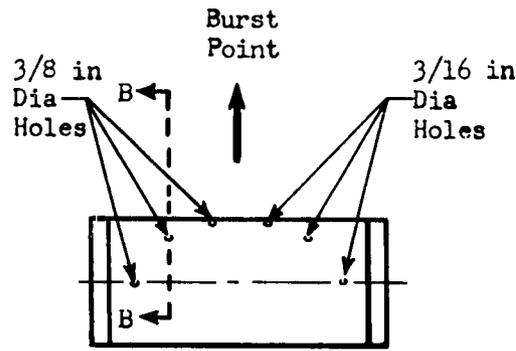
Figure 3.16 Cross Section of Hemispherical Holes on Cylinders

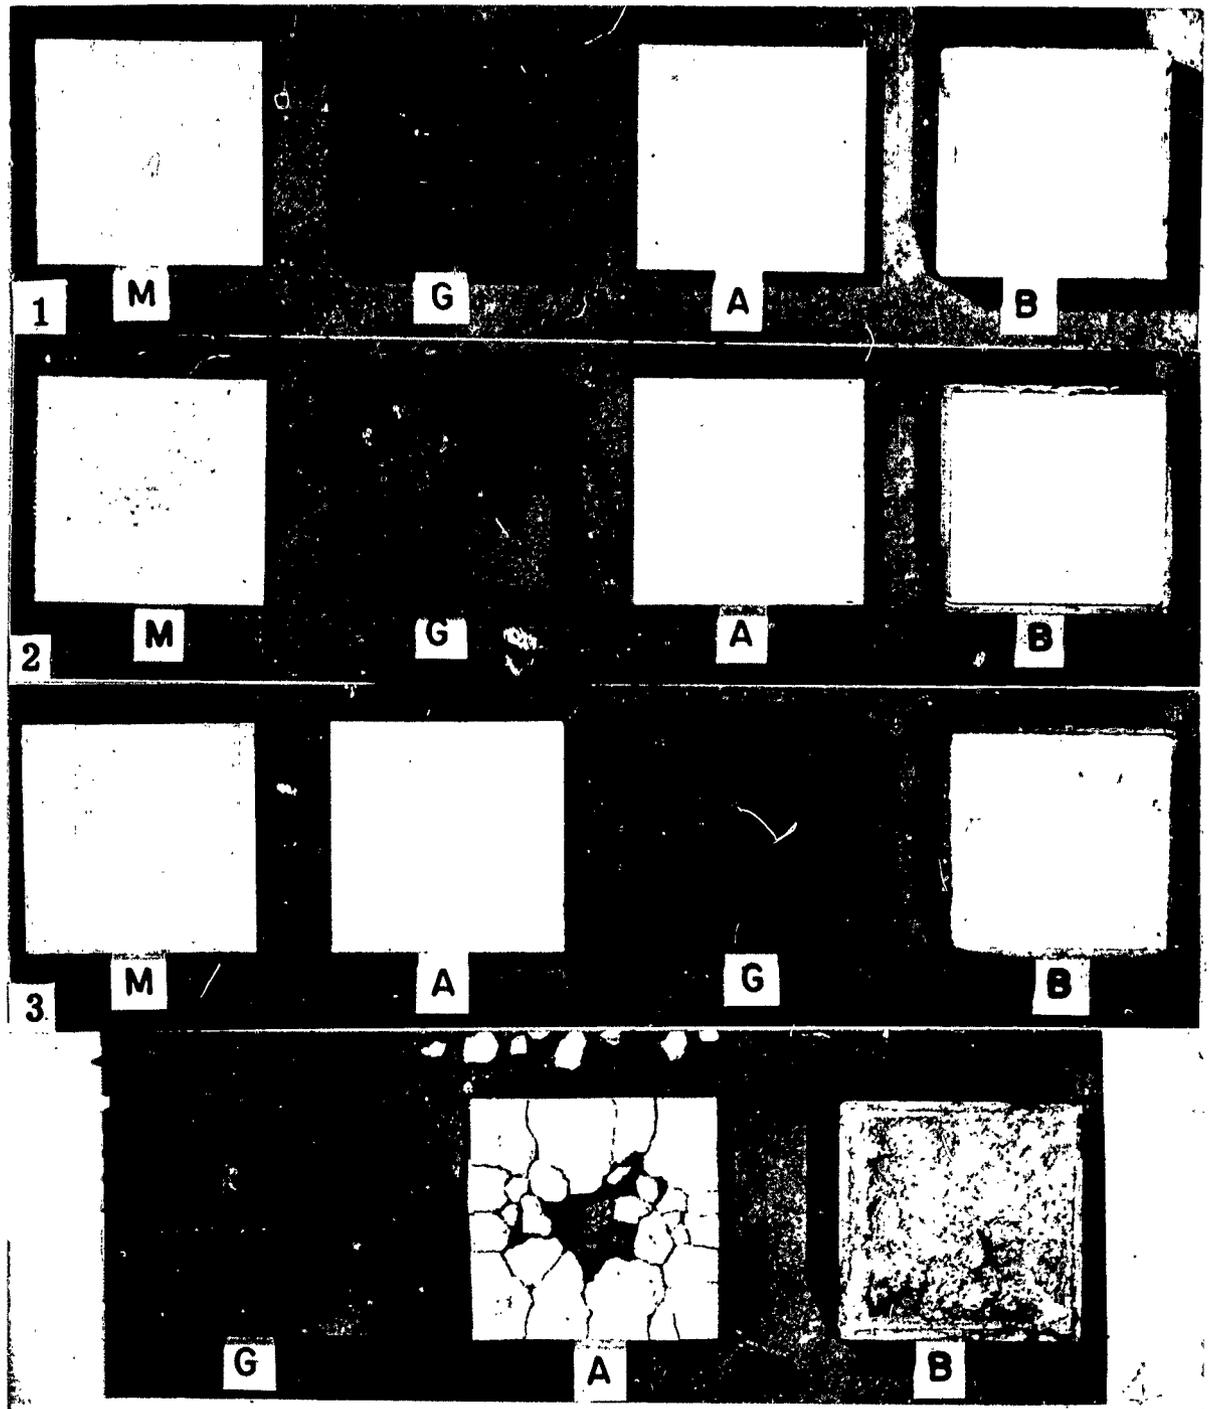
Figure 3.21 Post-Shot Photographs of Specimens Exposed on Pylons and Pipe Mount. B-Battelle; A-Armour; G-Graphite; M-Molybdenum. (1) Typical Pre-shot Specimens. (2) Range 3,100 feet (After Exposure). (3) Range 2,200 feet (After Exposure).(4) Range 1,100 feet (After Exposure).

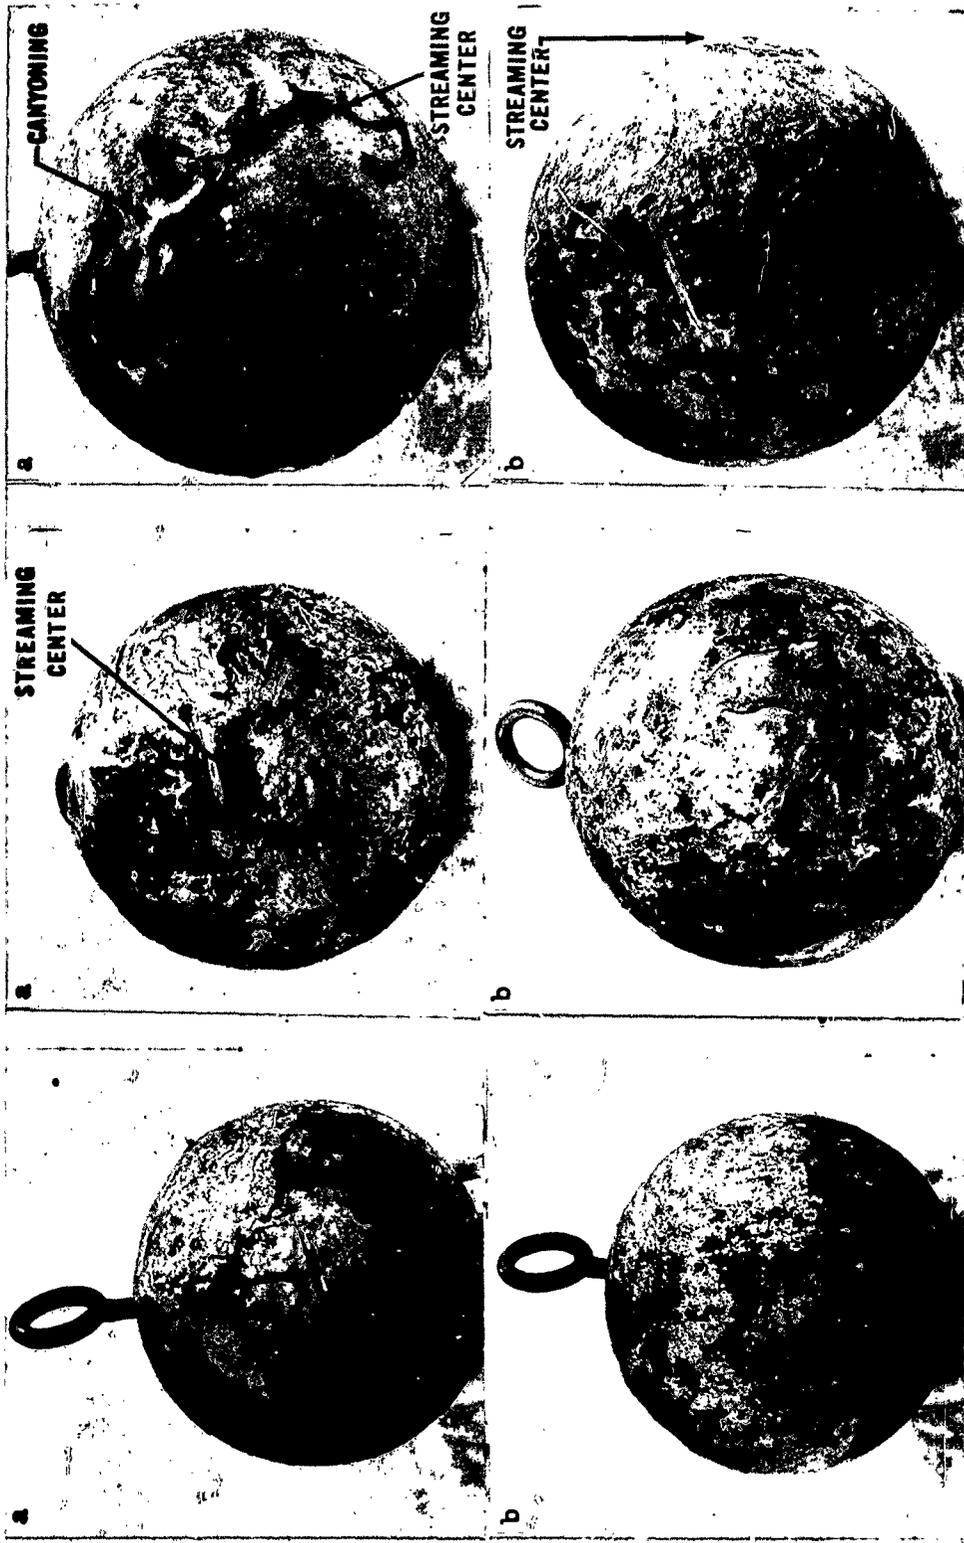
Figure A.7 Aluminum Sphere, Tower 2. (a) Showing Extreme Molten Metal Runs; (b) Side Opposite Metal Runs.

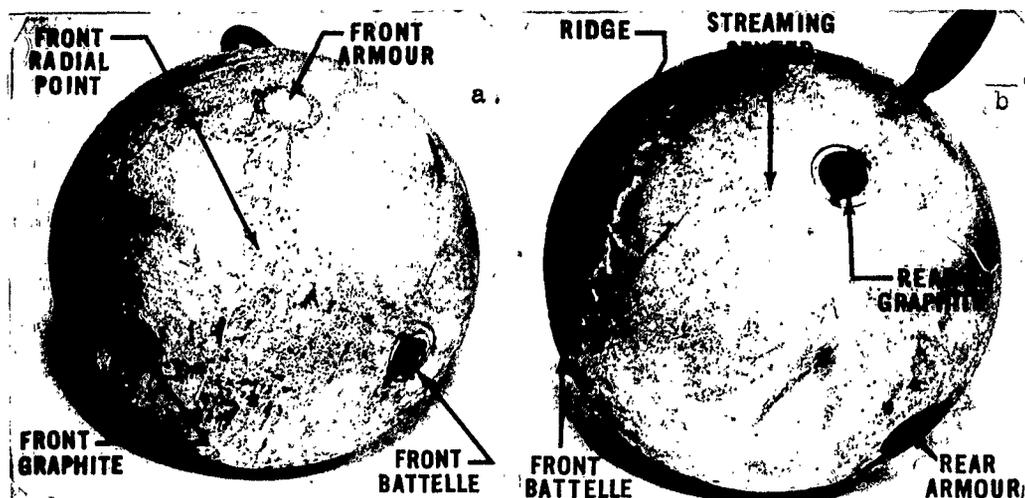
Figure A.15 Ceramic-Insert Sphere, Tower 5. (a) Front
Radial View; (b) Center of Shiny Streaming.

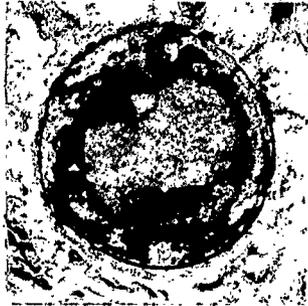
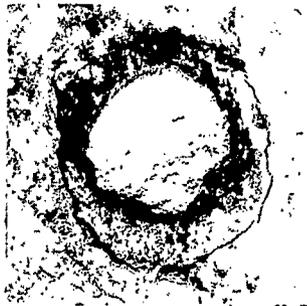
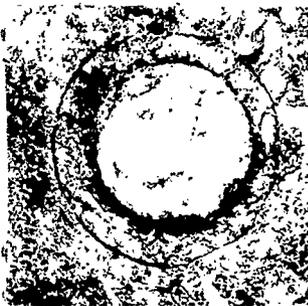
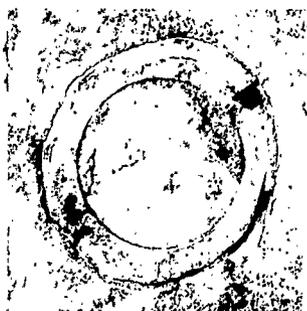
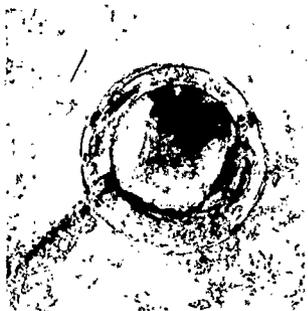
(b) Tower 1, Rear
(Note complete glaze.)

(c) Tower 2, Front
(Covered with Al.)

Figure A.16 Armour Ceramic Inserts After Exposure

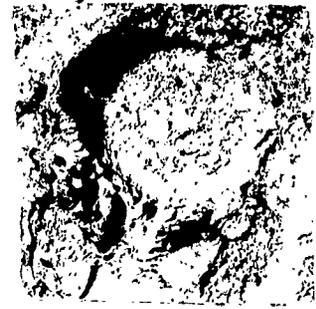
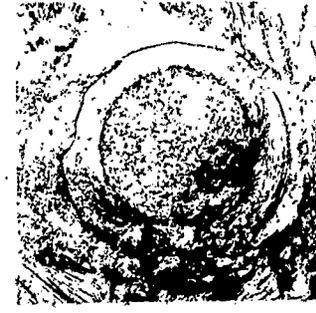
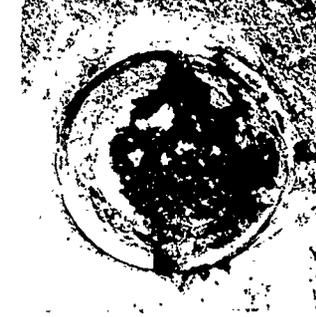
(a)   Tower 1, Front   (b)   Tower 1, Rear   (c)   Tower 2, Front
(Covered with Al.
See Figure 3.18.)

Figure A.17   Battelle Ceramic Inserts After Exposure

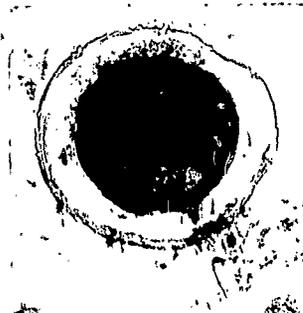
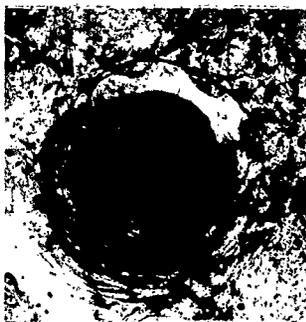
(a) Tower 1, Front
(Completely Gone)

(b) Tower 1, Rear
(Partially Broken Out)

(c) Tower 2, Front
(Covered with Al.)

(f) Tower 3, Rear
(See Figure 3.18)

Figure A.18 Graphite Inserts After Exposure

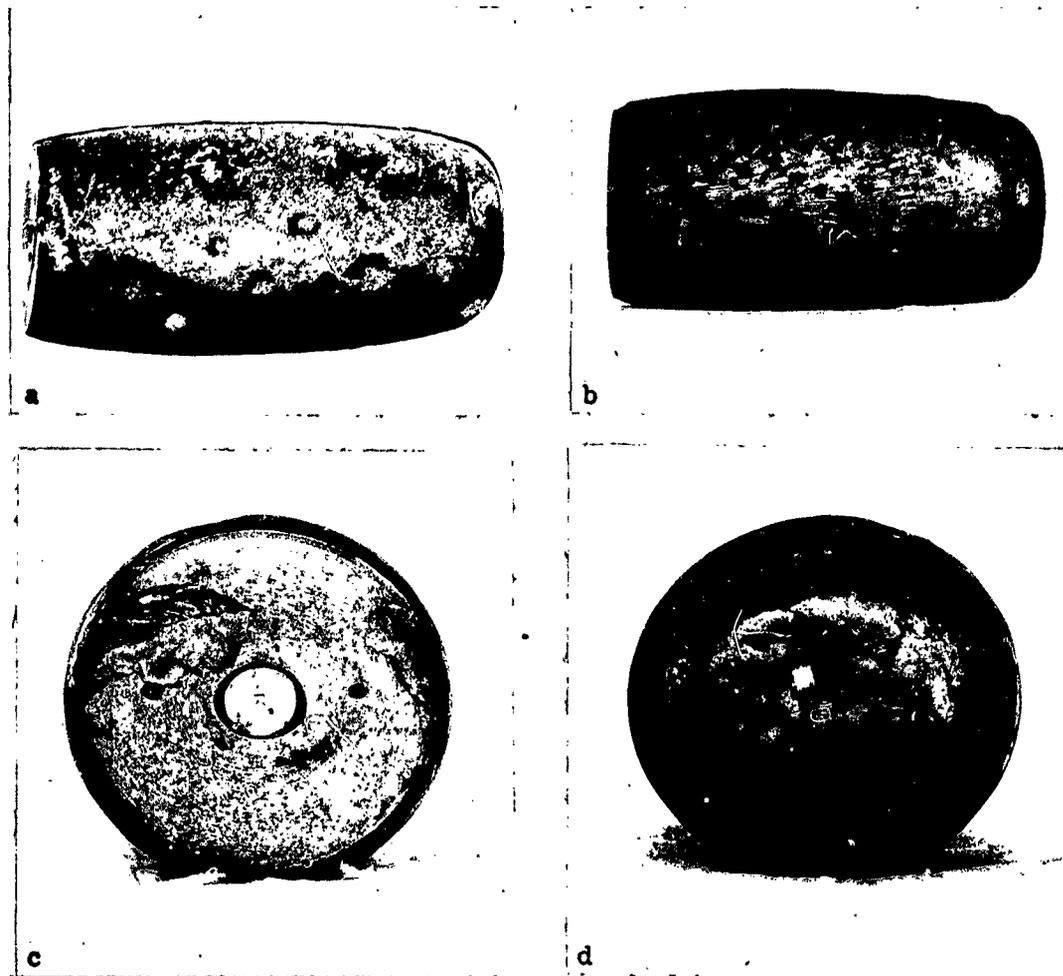
Figure A.20   Cylinder From Tower 1, Right Side, 1-in.-diameter Hole.
(a) Pock-Marked Side; (b) Side Opposite Pock Marks (Note streaming
pattern); (c) End Without Cap (Note numbered slug and two analysis
holes); (d) End With Cap.

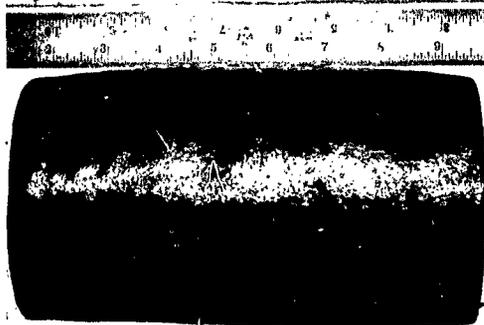
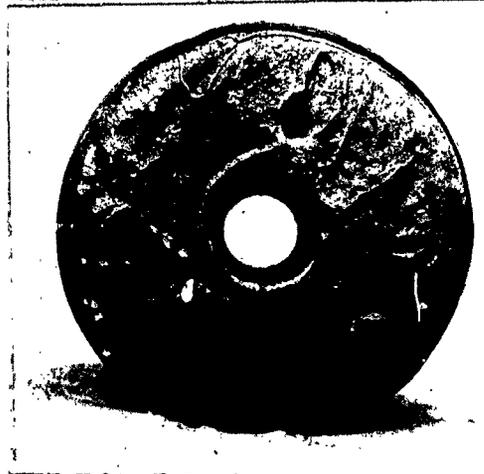
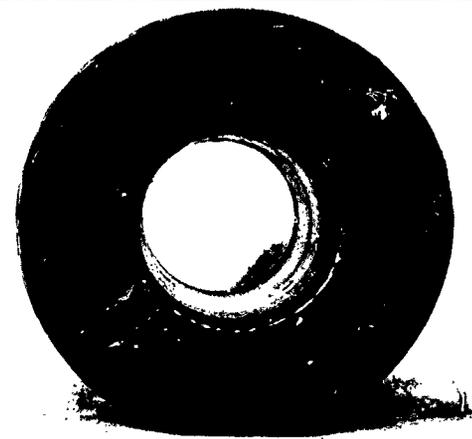
A.4.3 Tower 2, Left Side, 1-in. Hole (Ref. Figure A.21(a), (b), and (c). There were approximately eight pock marks in a relatively small area. The maximum depth below the surface was about 7/32 inch and most of the pocks were about 1/2 inch in diameter. Nearly all of the surface was wavy and irregular to depths of about 1/32 inch and was dark in color somewhat like hot rolled steel. There was some evidence of molten metal flow and splashes over the surface of the cylinder and especially over the ends as seen in Figure A.21(c). There was a slight streaming pattern observed on the side opposite the pock marks which, if attributable to impact with ground, would indicate the cylinder hit the ground approximately broad side. The inside of the hole was essentially undamaged with the machine marks still quite visible. The hole did not appear to be squashed but measurements given in Section 3.1.2 indicate that there was a slight amount of squashing sustained. The amount of barreling of the cylinder is shown pictorially in Figure A.21 (a) and is discussed in Section 3.1.2. Both caps were detached from the cylinder. The threaded shoulder was completely burned off leaving the corners rounded.

Figure A.21 Cylinders From Left Side (1-in. Hole) and Right Side
(2-in. Hole) of Tower 2

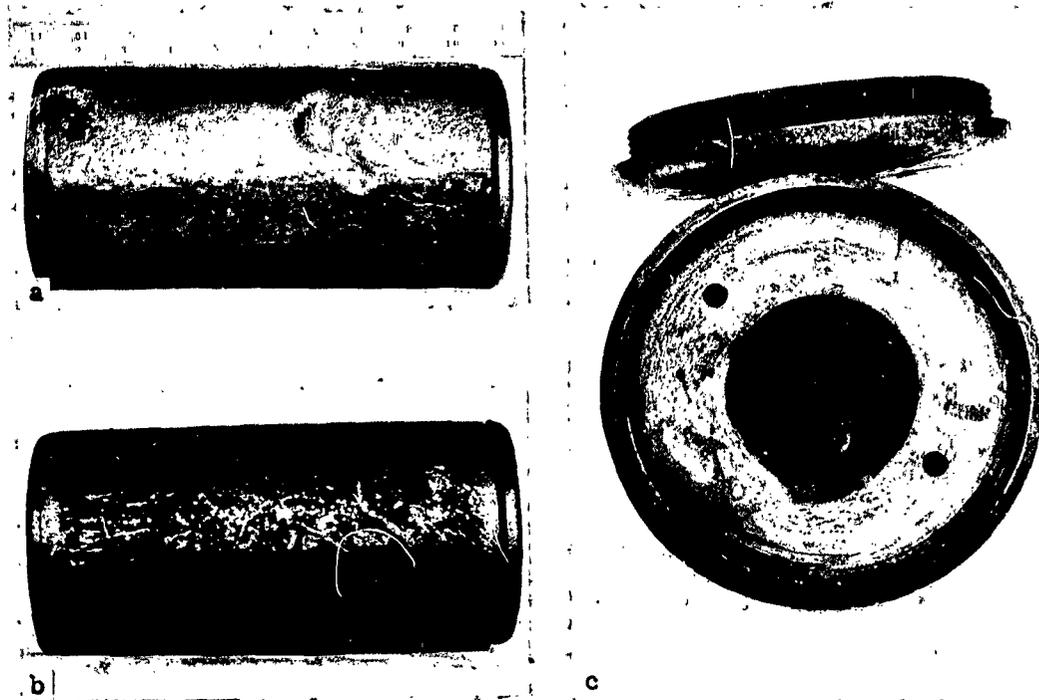
Figure A.22 Cylinder From Tower 3, Left Side, 2-in. Hole.
(a) Pock Marked Side; (b) Side Opposite Pock Marks; (c)
End View.

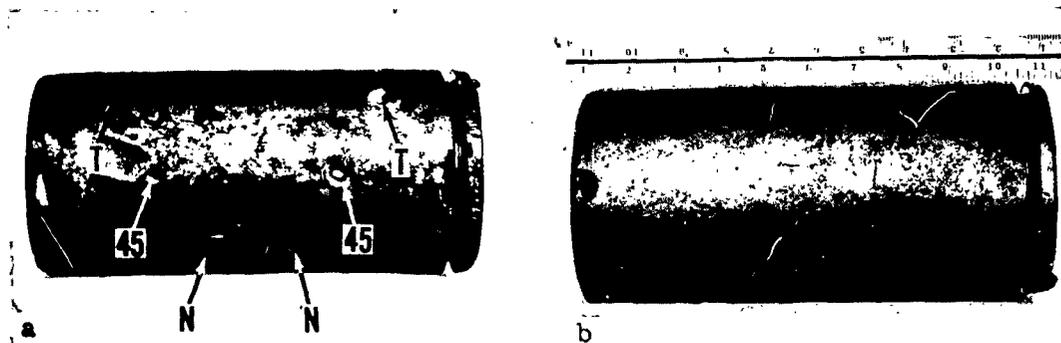
Figure A.23 Cylinder From Tower 3, Right Side, 3-in. Hole
(Refer to Figure 3.17). (a) Front of Cylinder (Note hemispherical
holes); (b) Rear of Cylinder.

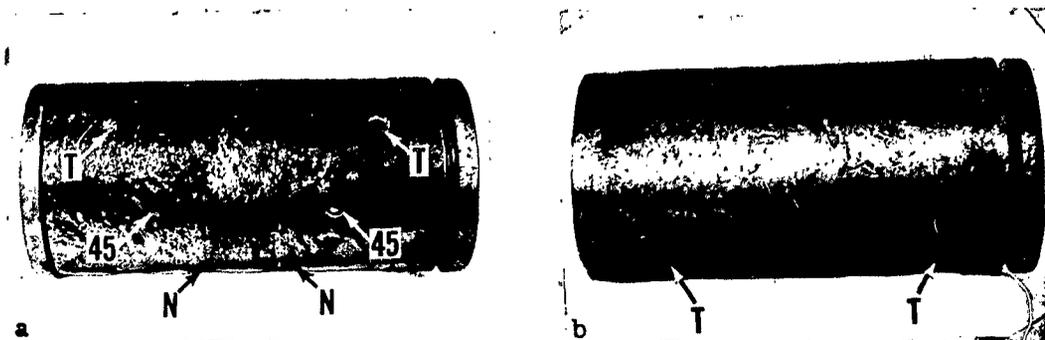
Figure A.24   Cylinder From Tower 4, Left Side, 3-in. Hole
(Refer to Figure 3.17). (a) Front View (Note hemispherical
holes); (b) Rear View (Note two holes which had tangential
flow).

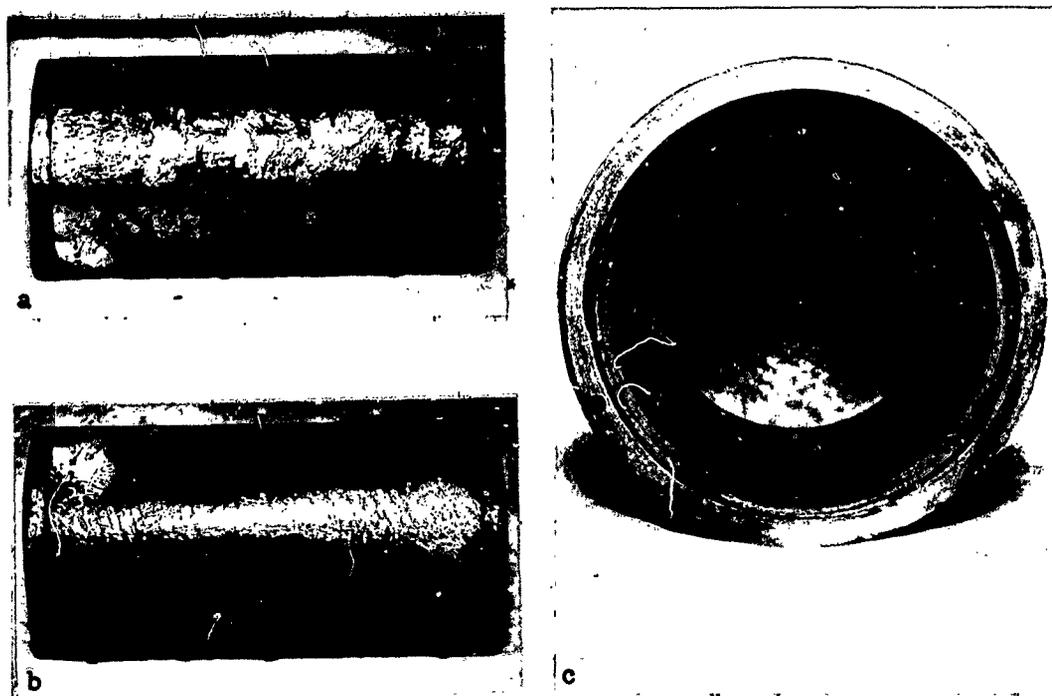
Figure A.25   Cylinder From Tower 4, Right Side, 4-in. Hole.
(a) Side with Shiny Metal Splashes; (b) Side Opposite Shiny
Metal Splashes (Note white spot is paint); (c) End View.

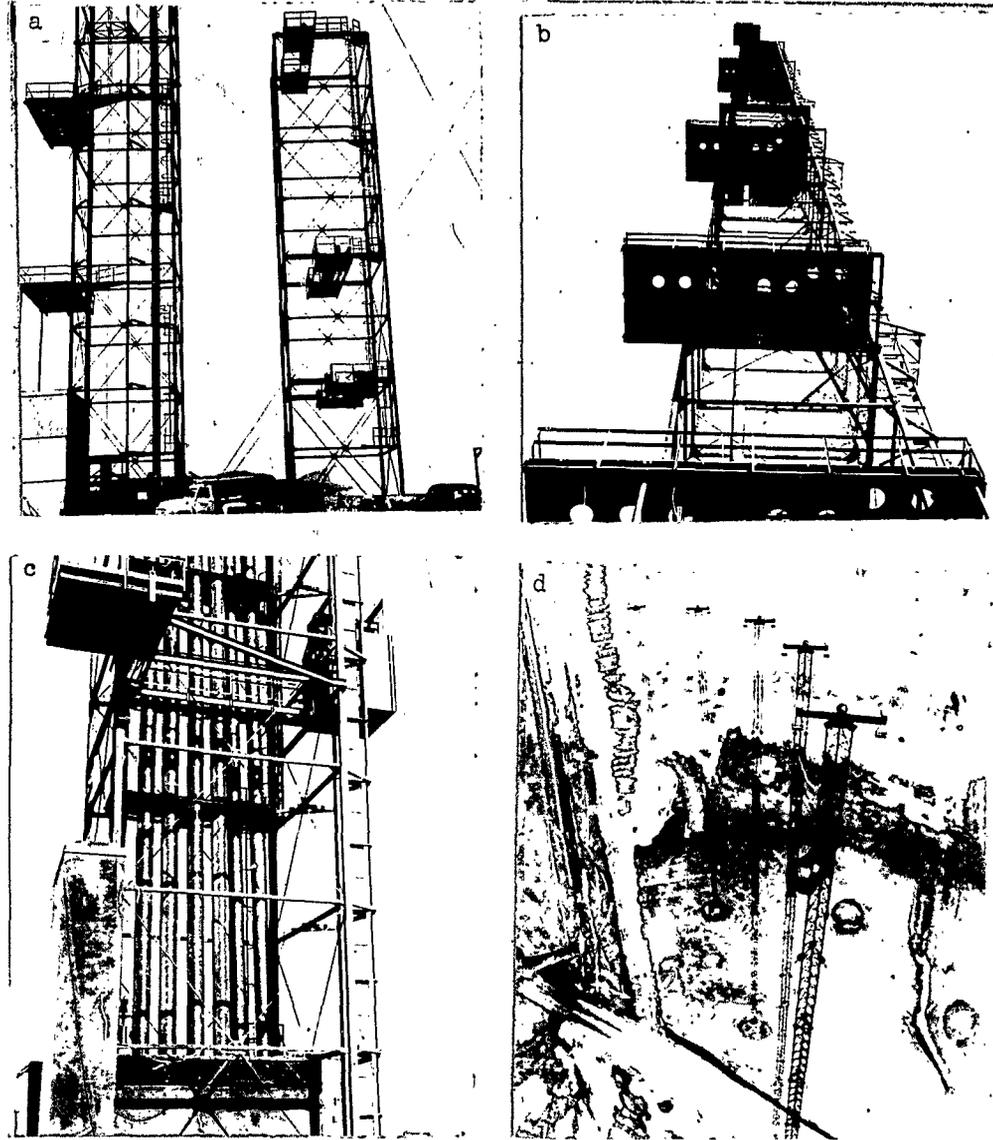
Figure C.3 Close-up Views of Various Towers. (a) Shot 8 Tower, Base Portion and Auxiliary Tower. (b) Shot 8 Tower, Steel Platforms. (c) Shot 13 Tower, Base Portion, Showing Seven Large Tubes. (d) View of TV Towers From Shot Cab of Shot 12.

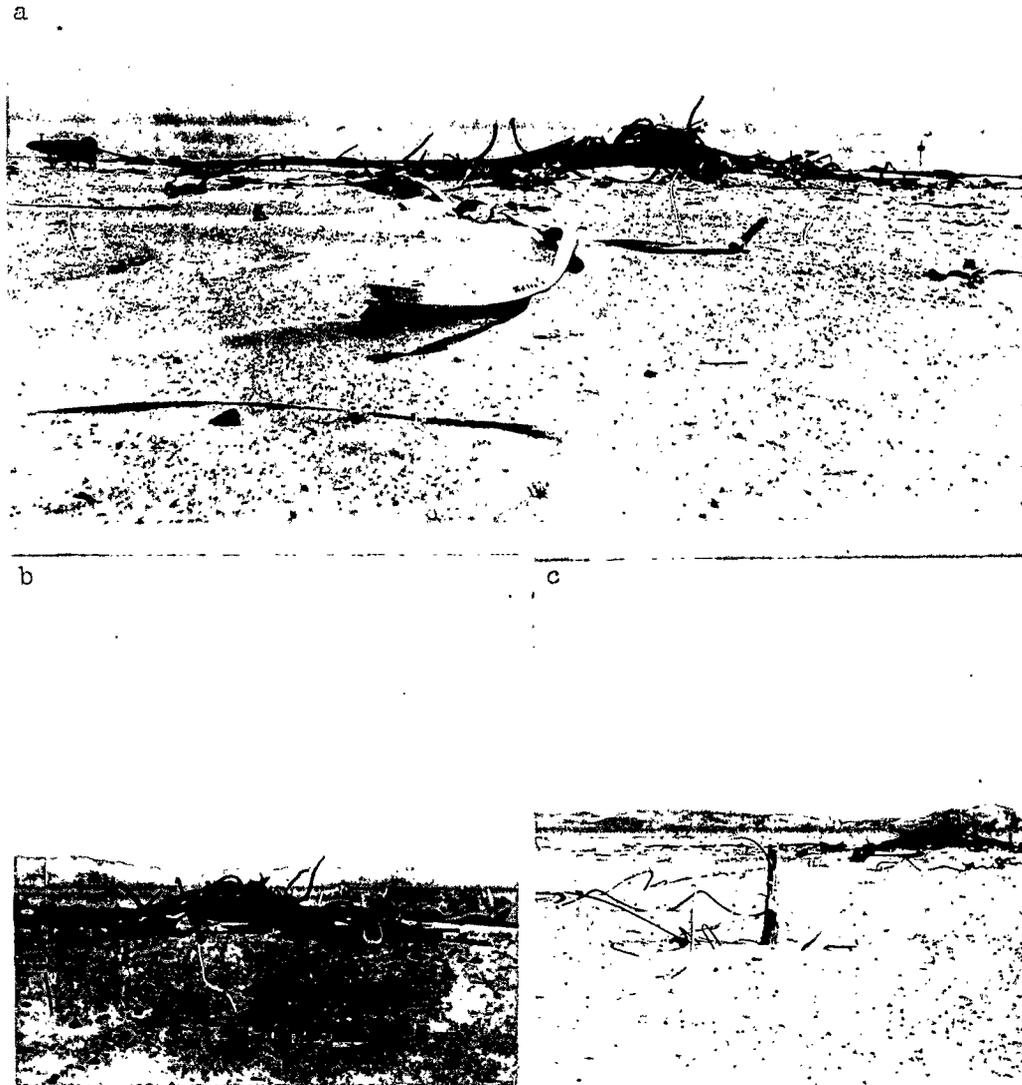
Figure C.4 Shot 2 Tower Wreckage. (a) General View; (b) Close-up View; (c) Guy Anchor and Cable.

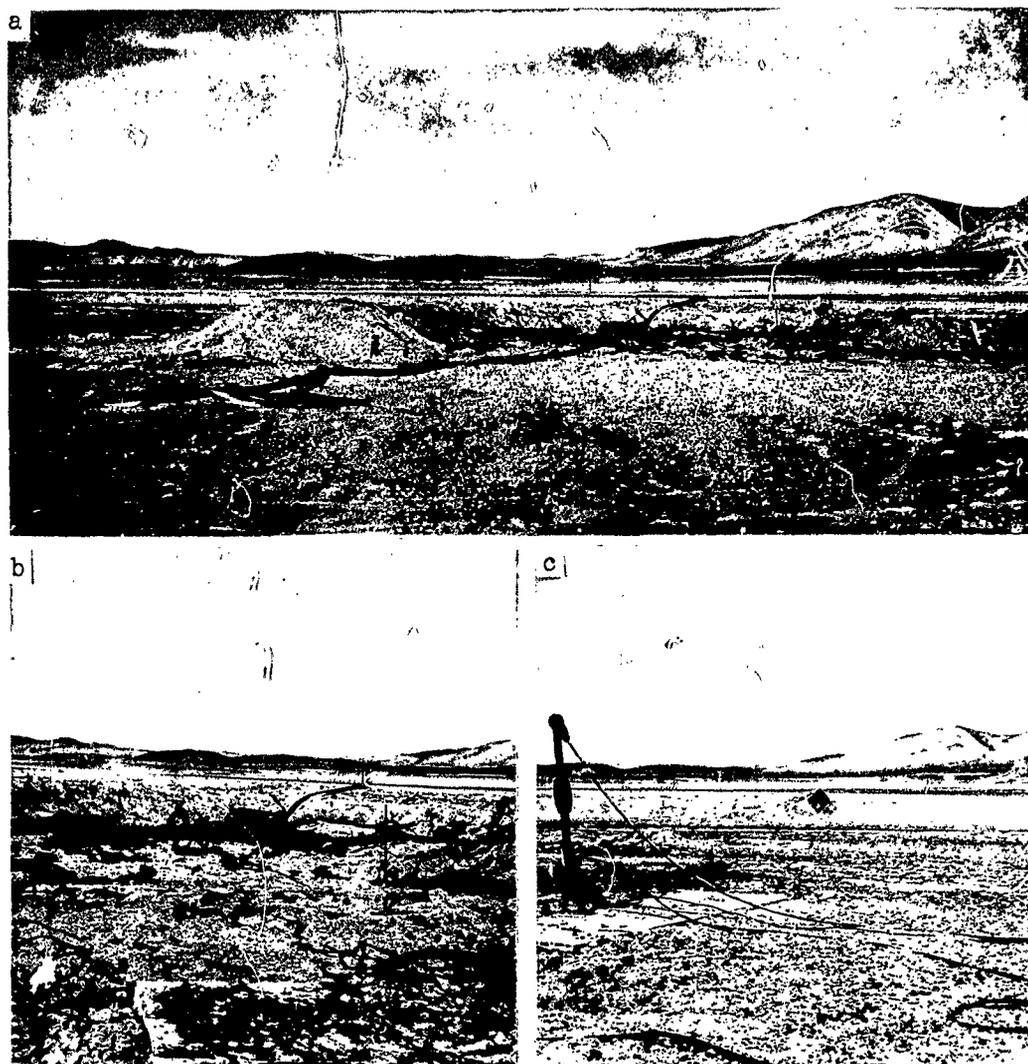
Figure C.5 Shot 3 Tower Wreckage. (a) General View; (b) Close-up View;
(c) Guy Cable and Turnbuckle.
