Operation

TEAPOT

Project 5.4

EVALUATION OF FIREBALL LETHALITY
USING BASIC MISSILE STRUCTURES (C)

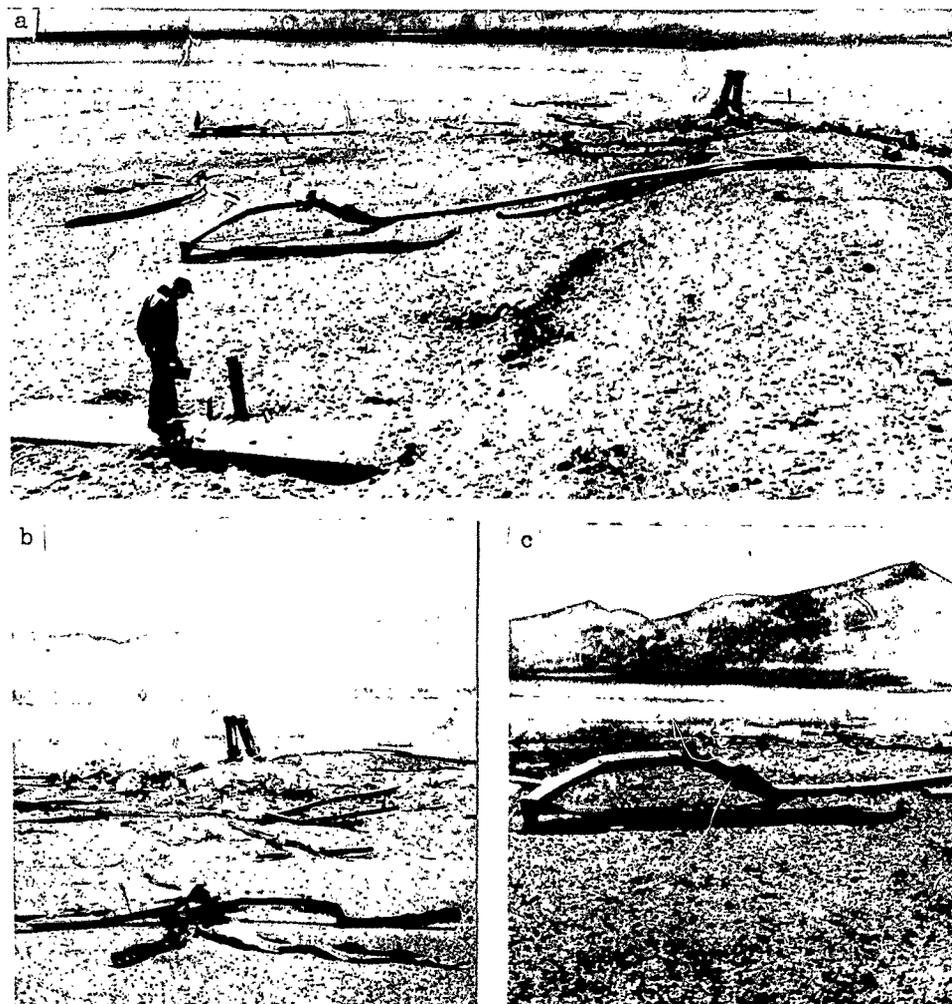
C.2.3 Shot 4 (500-ft, 100-ton Square Tower). There were two large pipes about six feet high still on the tower base as seen in Figure C.6 (a) and (b). Only the main support members of this tower, however, remained to any extent. These members were scattered off to one side of the tower, as seen in Figure C.6(a), rather than laid out radially as

noted on Shots 2 and 3. One piece of the tower leg which was still intact was about 100 feet as seen in the foreground of Figure C.6(a).
The end of this was broken off at a tower splice with another tower member about 50-ft long also broken at a splice lying nearby. It is believed that these two members were from the same tower leg which indicates that nearly 150 feet of this tower leg was essentially undamaged.
The other end of the 75-ft member was squashed, split, and showed evidence of thermal damage which is typical of the top of remaining main support members of all of the towers. Other main support members found were less than 150 feet; probably about 100 to 125-ft long. Most of the

Figure C.6 Shot 4 Tower Wreckage. (a) General View; (b) Close-up View of Tower Debris; (c) Main Support Member.

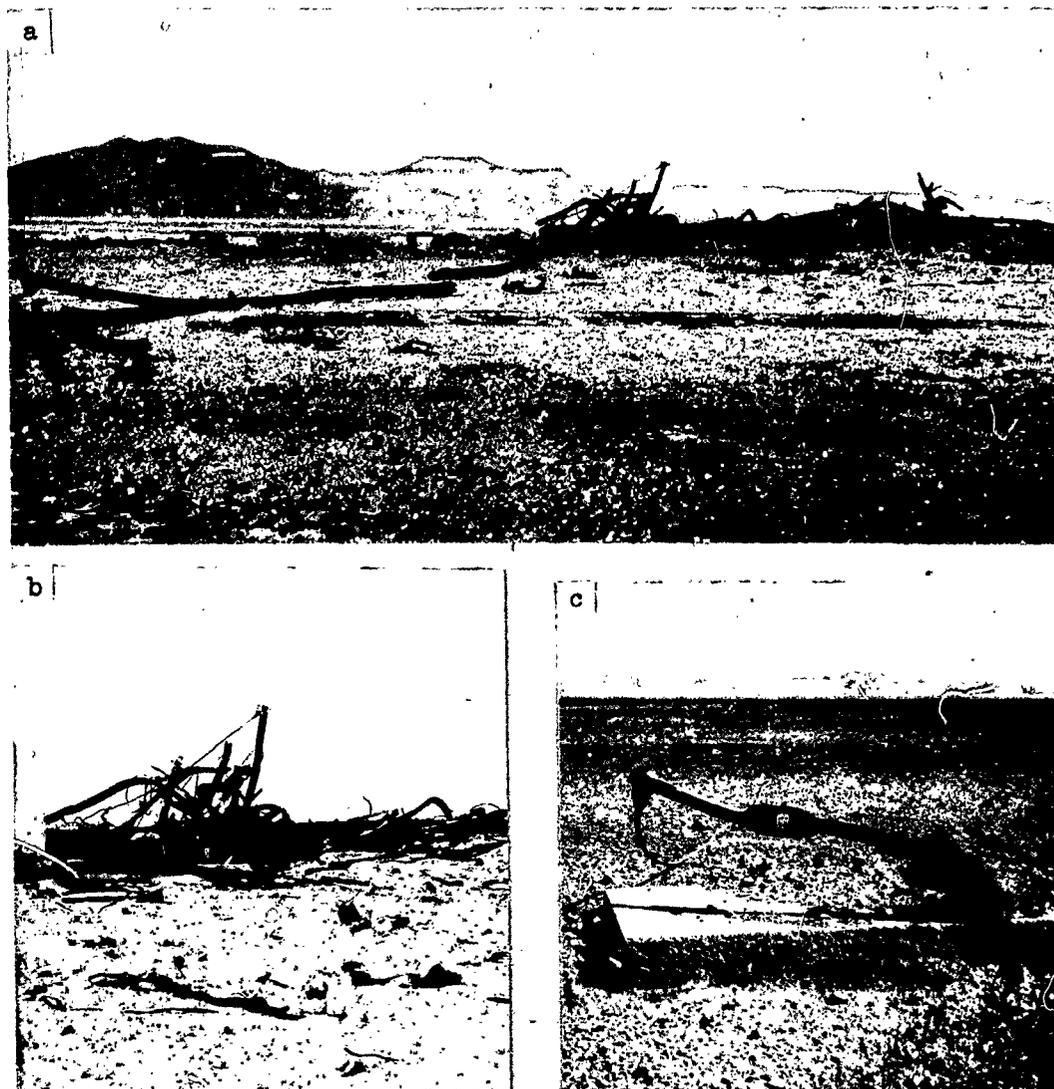
Figure C.9 Shot 8 Tower Wreckage. (a) General View; (b) Close-up View; (c) Guy Cable and Turnbuckle.

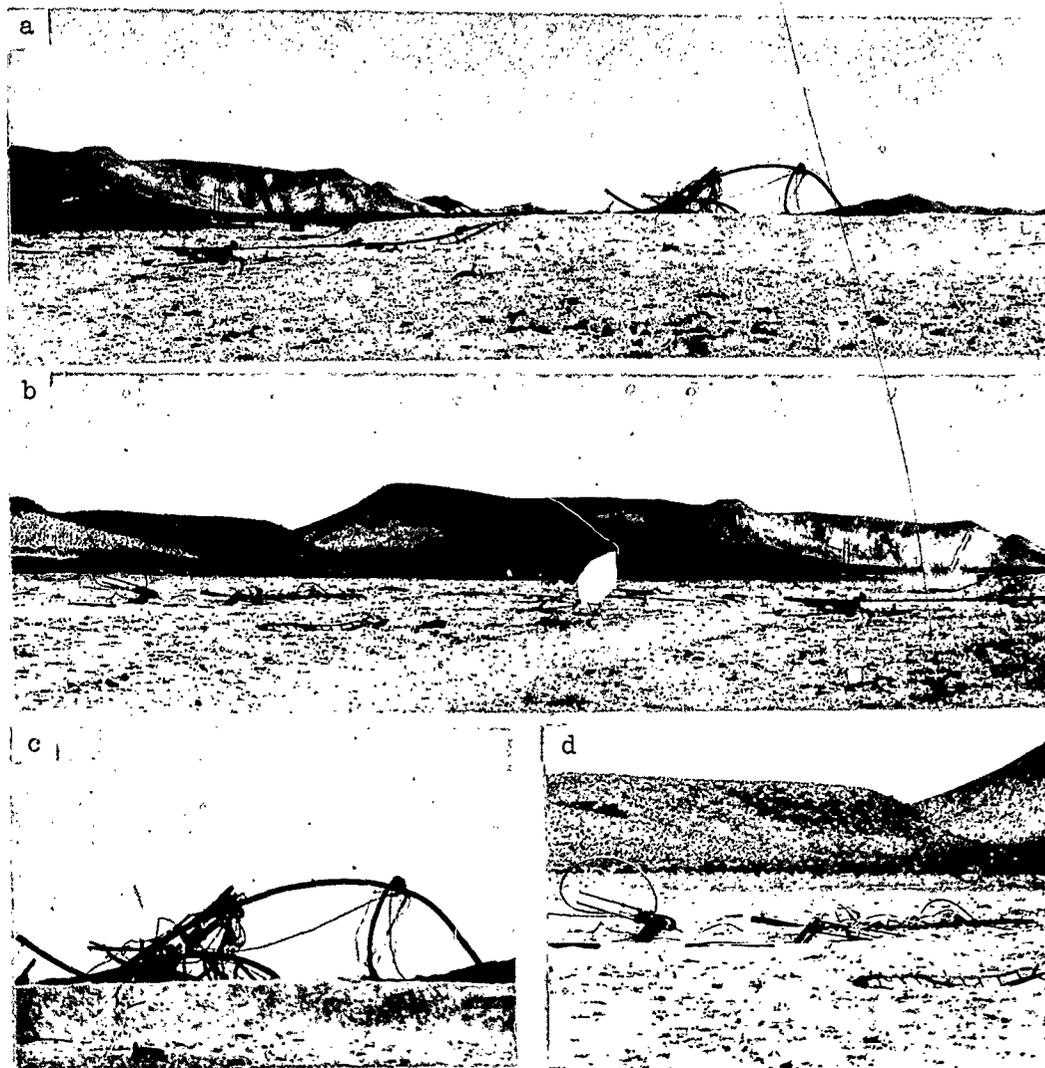
Figure C.10 Shot 11 Tower Wreckage. (a) General View; (b) Main Support
Member and Guy Anchors; (c) Close-up View; (d) Guy Cables and Deadmen.

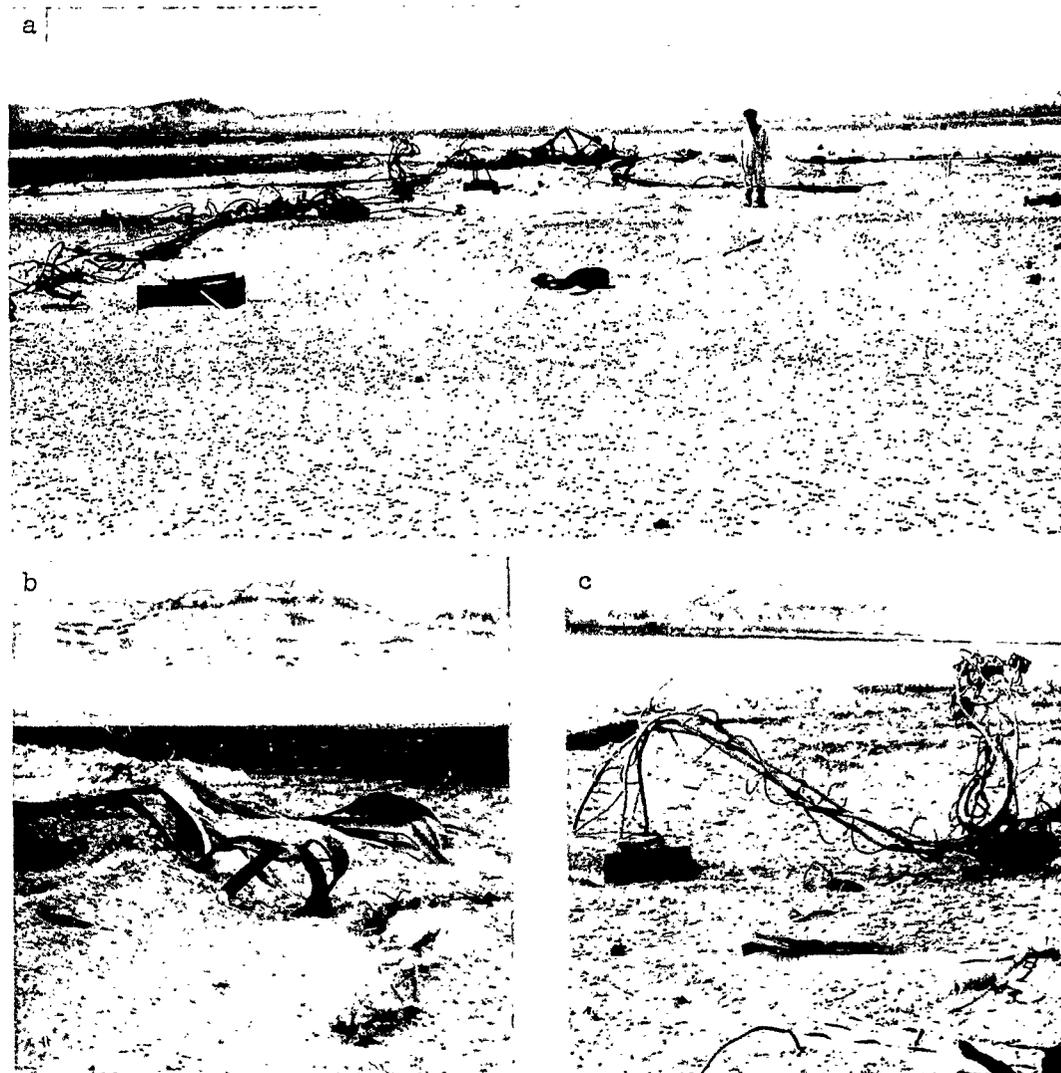
remains were at or near the base of the tower as seen in Figure 3.1 and
C.11(a). About 225 feet of the tower legs were still intact with the
top 25 to 50 feet being crushed, split, and slightly melted as seen in
Figure C.11(b). This was typical of most of the shot towers. Much of
the elevator cage could still be seen at ground zero. The hoist pulley
from the top of the elevator cage was still attached and appeared to be
essentially undamaged. All of the lower guy cables were still attached
to the burnbuckle and deadmen and were about 300-ft long. All of the
turnbuckles for the top guy cables were detached from their base but were
located within 100 to 200 feet of their original position. Most of these
turnbuckles were still attached to the guy cables. A cable junction fix-
ture (similar to that seen in Figure C.8(c)) which was originally 353
feet from the burst point was found and showed only a small amount of

C.2.9 Television Towers. The television towers were found in such a twisted form (see Figure 3.1 and C.11(c)) that it was difficult to

Figure C.11 Shot 12 Tower Wreckage. (a) General View; (b) Top End of Tower Leg; (c) Close-up View of TV Tower.
