Good Stuff

ISSUE NO. 2

This Newsletter is meant as an information document. It's contents are not necessarily Company Policy. It's a means by which LCG Product Support can distribute some tidbits of information to you.

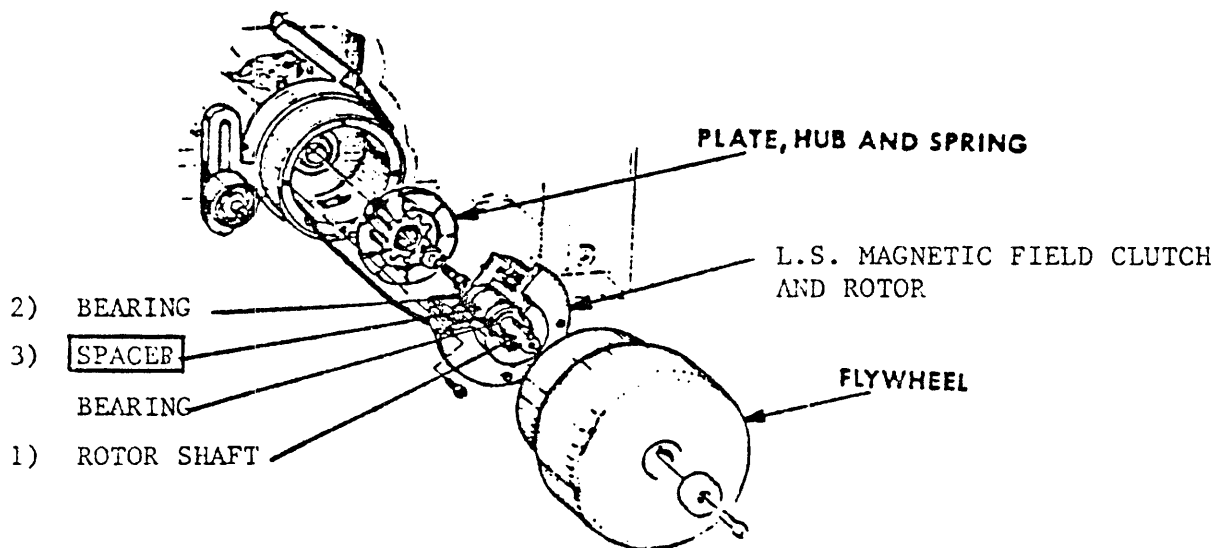
Take the spacer out of the old clutch assembly and install it in the new one. (The end of the rotor shaft might have to be filed down to get it out of the clutch, before the spacer can be removed.)

NOTE: REMOVE IN THIS ORDER:
1, 2, 3,

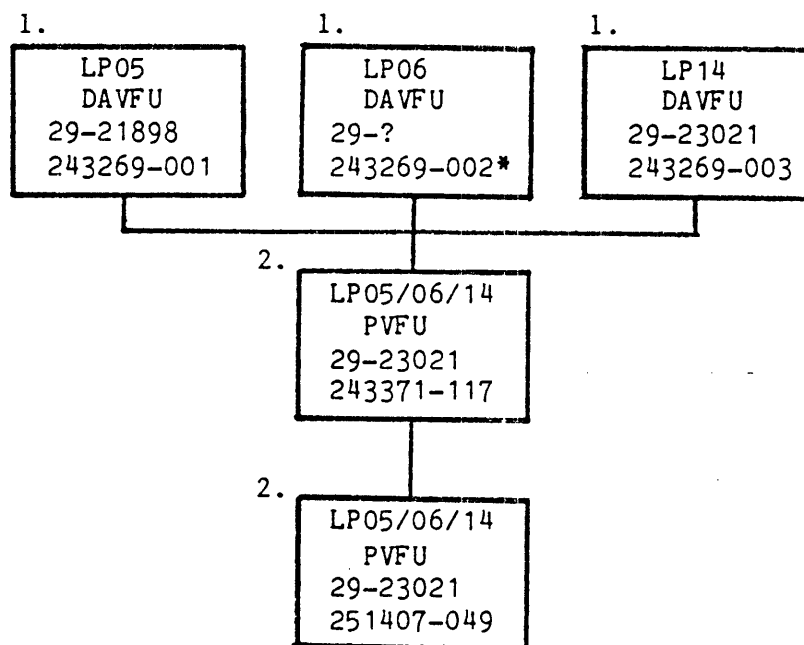
* The Vendor Part Number shown on the LP06 RSL was 243269-001. It should have been 243269-002.

1. The old DAVFU, DEC Part Number 29-21898 and Vendor Part Number 243269-XXX, have been discontinued and are no longer available.
2. Both PVFU, Vendor Part Number's 243371-117 and 251407-049 are cross-compatible and interchangeable.

When replacing the old DAVFU with the new PVFU (see chart below) the cable which plugged into "J2" of the old DAVFU now connects to "J3" of the new PVFU.

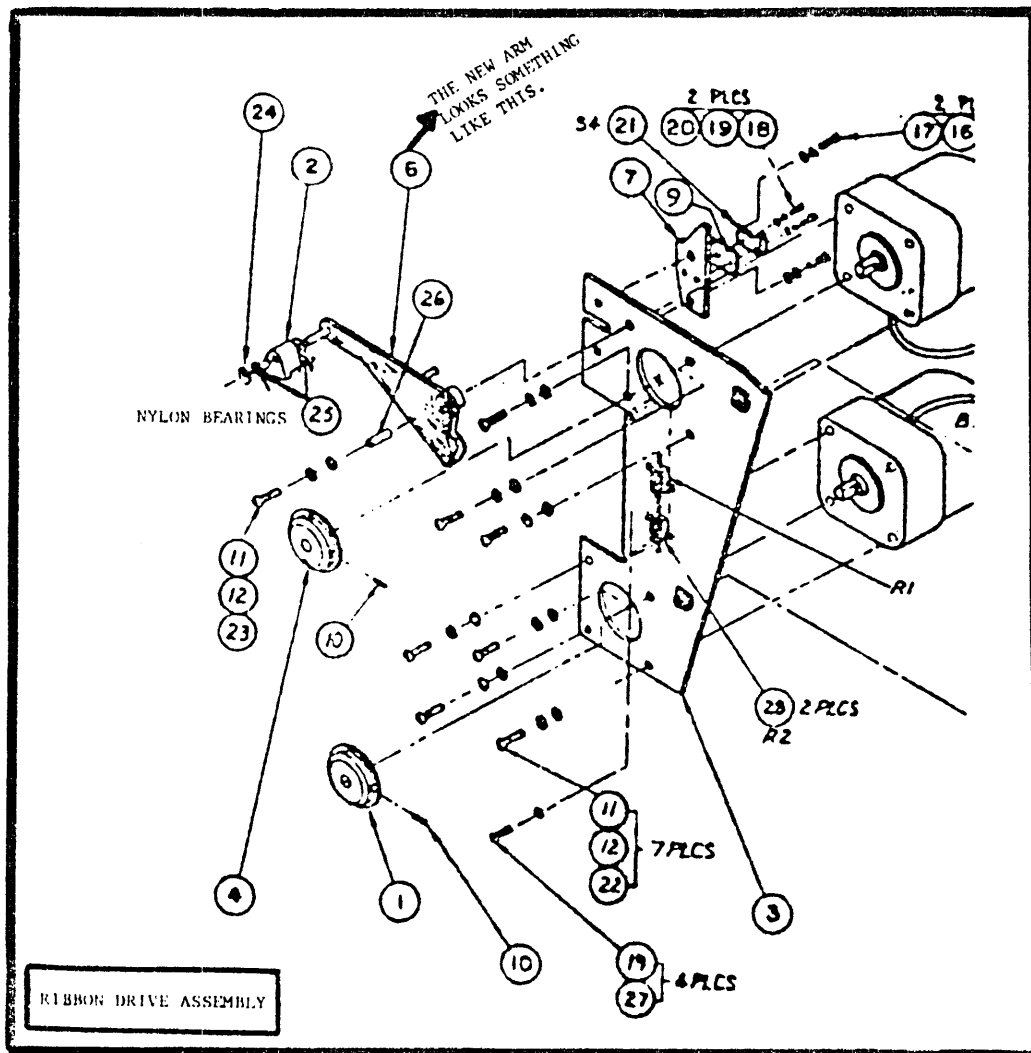
When replacing the ribbon skew "pivot arm" on the LP07, one thing that you must be sure of is that the two nylon bearings that fit into the pivot arm cam, are in place. The reason for this is that the new pivot arm is shorter than the old one and this causes the cam to land across both ribbon reverse bars. If the nylon bearings are not in place, the cam will be at a ground potential and will short the two reverse bars.

The problem occurs when the ribbon reverses to start moving up. Now, because of the shorting action of the cam, the ribbon tries to reverse in the other direction and the ribbon gets hung up trying to reverse in both directions at the same time. This, of course, plays havoc on the ribbon.
