Problem Determination Guide

IBM 3745 Communication Controller
Models 130, 150, 170, 210, 310, 410, and 610

IBM 3746 Expansion Unit
Models A11, A12, L13, L14, and L15

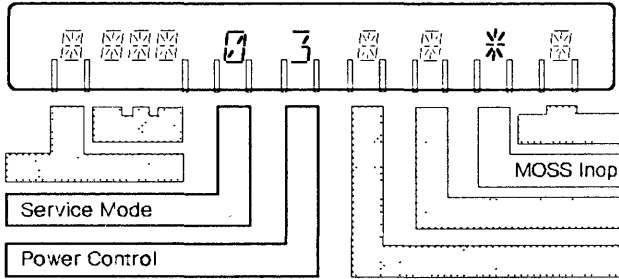
This drawing represents the control panel display. The control panel is fully illustrated and explained in the *3745 Basic Operations Guide* and on the *3745 Control Panel Reference Card*. (See Appendix A, "Control Panel.")

The highlighted name (for example: Service Mode) identifies the display position or the indicator to look at.

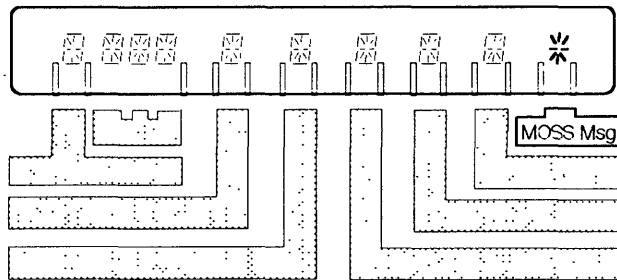
When an alarm is generated, the MOSS Msg indicator is lit on the control panel.

- If the console operator is logged on, the alarm is displayed and an audible signal is emitted.
- If the console operator is not logged on, log it on (refer to the 3745 *Advanced Operations Guide*).

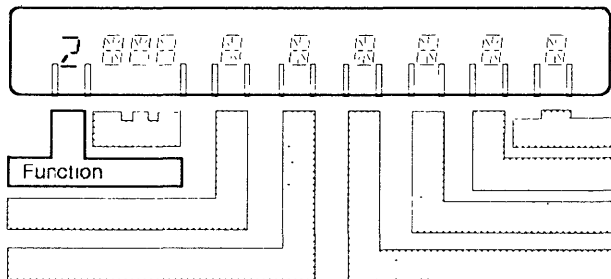
- Dump MOSS from the control panel. Press **Function** repeatedly until **2** is displayed; then press **Validate**:

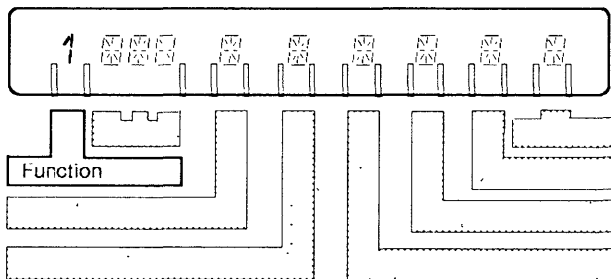
- Re-IML MOSS from the control panel. Press **Function** repeatedly until **1** is displayed; then press **Validate**:

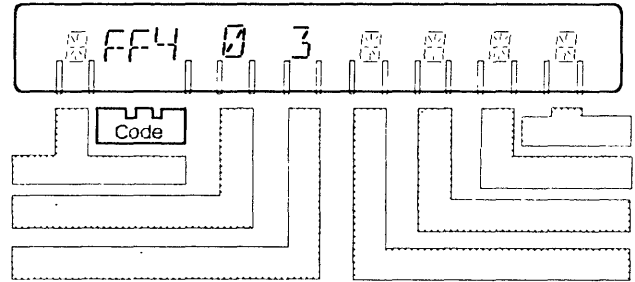
- The progression of a function (for example, IPL).
- The status of the components.
- An error. In this case, the code blinks.

Code	Explanation and Action
0 0 0	3745 IPL has been successfully completed. The control program is loaded and MOSS is online.
0 0 1 or 0 0 2

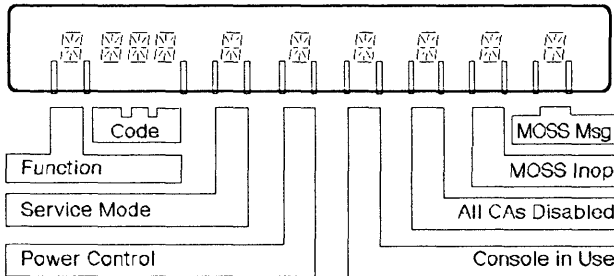
Nothing appears on the control panel display:

- Check your installation (for example, ac circuit breakers).
- If there is no problem in the installation:

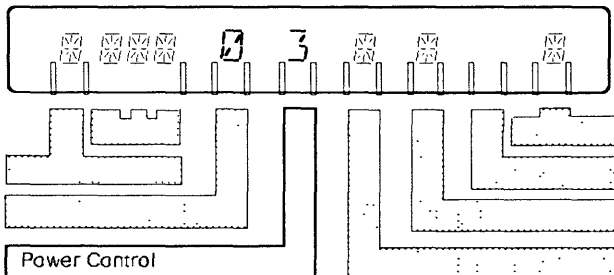
Power control on the control panel display is: **1, 2, or 3**

- If **1** Go to page 4-2
- If **2** Go to page 4-3
- If **3**
 - Power off
 - Wait 10 seconds
 - Select the function 1 (MOSS IML)
 - Power on
 - If the problem persists:

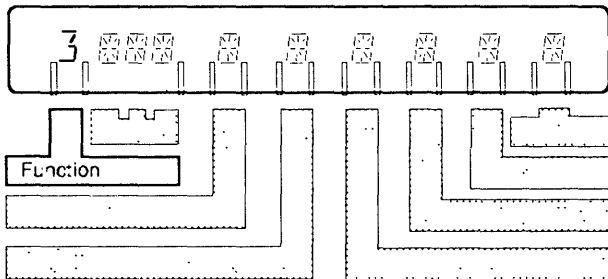
- 1** Press **Function** repeatedly until **3** is displayed, then press **Validate**. This informs the remote or RSF operator that you want to log on.

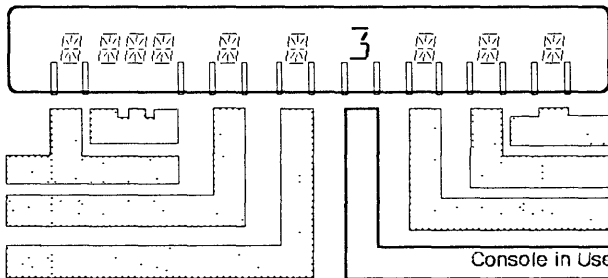
- 2** When **Console in Use** displays **3**, the remote or RSF console is disconnected. You may log on at the local console. If **3** does not appear, go to next step.

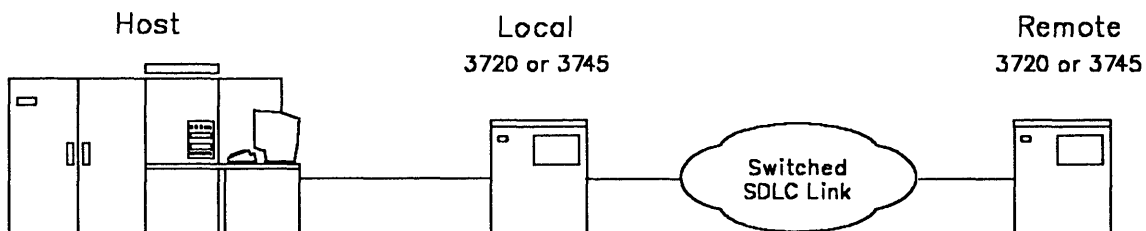
Figure 8-1. Initial Loading on Switched/Nonswitched SDLC and Nonswitched X.21 Links

- The remote initial loading can be performed by using VTAM* commands from the host.
- A link IPL port (LKP) must be defined in the remote controller.

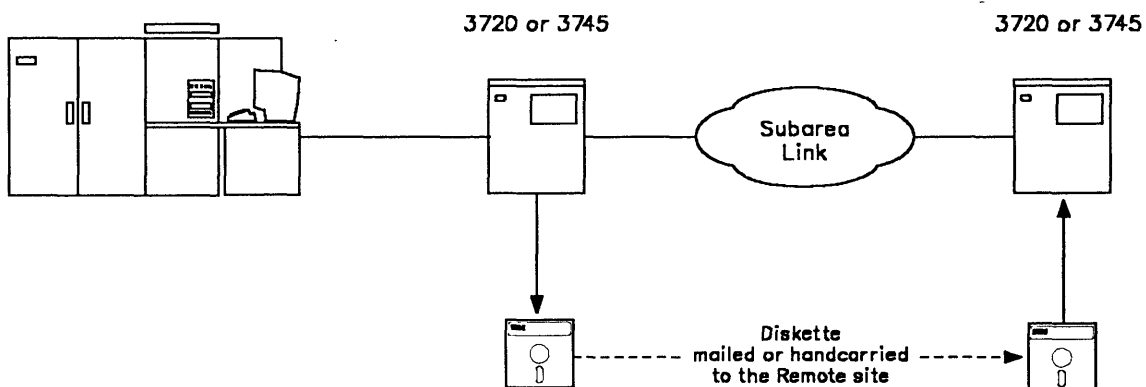
Figure 8-2. Initial Loading on Switched X.21, X.25 (SVC/PVC), and Token-Ring Links

- The remote initial loading can be performed only by using the diskette management procedure. Refer to the *3720/3745 Remote Loading/Activation Guide* or to the MOSS DII function described in the *3745 Advanced Operations Guide*.
- Those links do not require a link IPL port (LKP) definition in the remote controller.

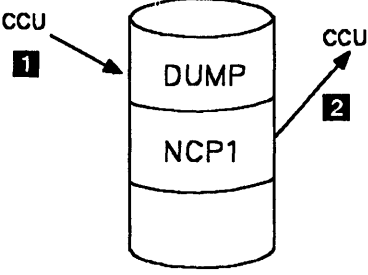
<p>Event A</p> <p>It is assumed that AUTO DUMP/LOAD=YES and ACTIVE LOAD MODULE=NCP1 are displayed on the MOSS DII screen.</p> <p>If the NCP1 fails or a hardcheck occurs:</p> <ul style="list-style-type: none">• 1 The controller dumps NCP1 (which failed) onto the hard disk.• 2 The controller reloads NCP1 from the hard disk, and you do not have to reload NCP using a diskette or an SDLC link.

<p>After NCP1 abend</p>
---	--

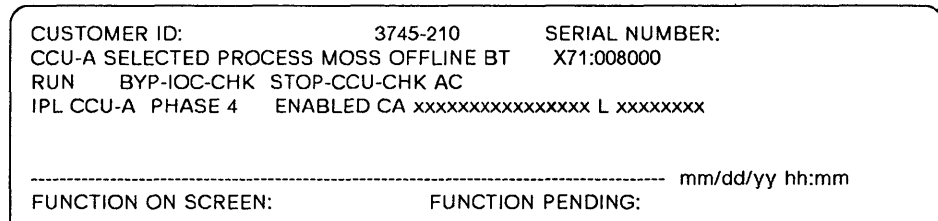
Figure 8-3. MSA Example with IPL Information

CCU/scanner IPL information is displayed on line 4 for CCU-A, and on line 7 for CCU-B.

A short time after successful completion of the IPL, these lines are cleared and line 7 is filled by dashes plus the date and time.

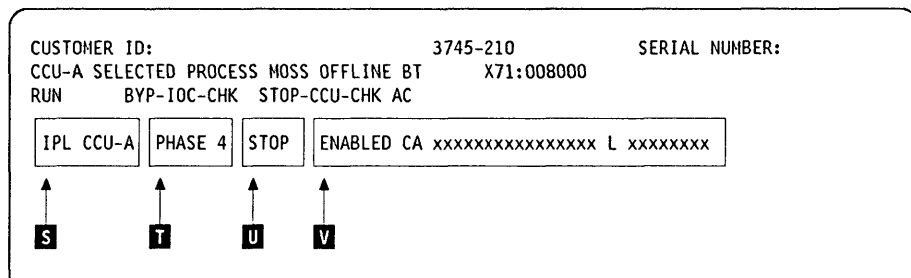
Figure 8-4. Fields of the IPL Information in the MSA

This picture shows the breakdown of the IPL information fields in line 4 (CCU A IPL) or 7 (CCU B IPL).

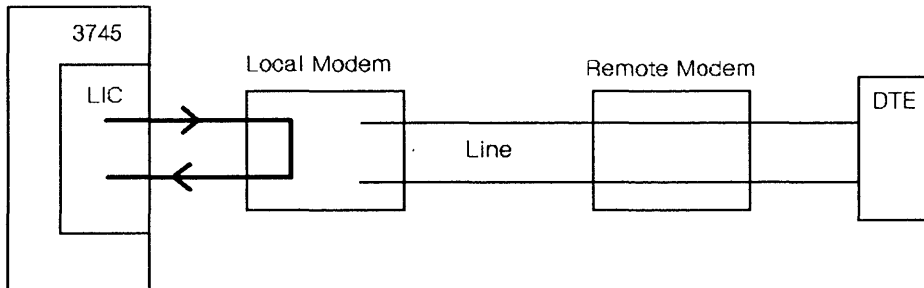
3. Local modem loopback test (loop 3)

Refer to the MOSS WTT function in the *3745 Advanced Operations Guide*.

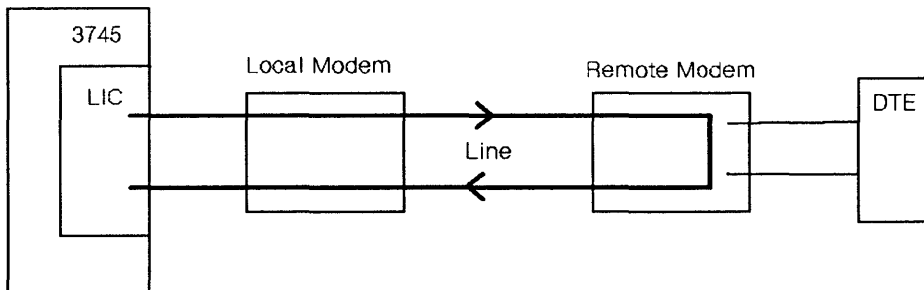
4. Remote modem loopback test (loop 2):

Refer to the MOSS WTT function in the *3745 Advanced Operations Guide*.

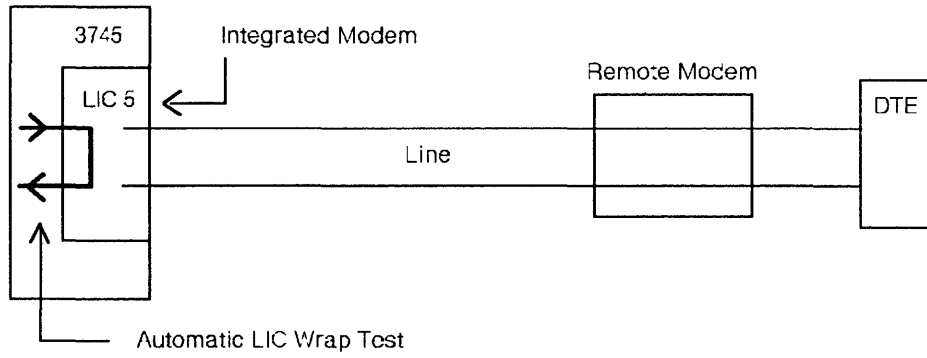
Figure 9-2. Automatic LIC Wrap Test on LIC5

5 Press the following keys to select the automatic wrap test at LIC level:

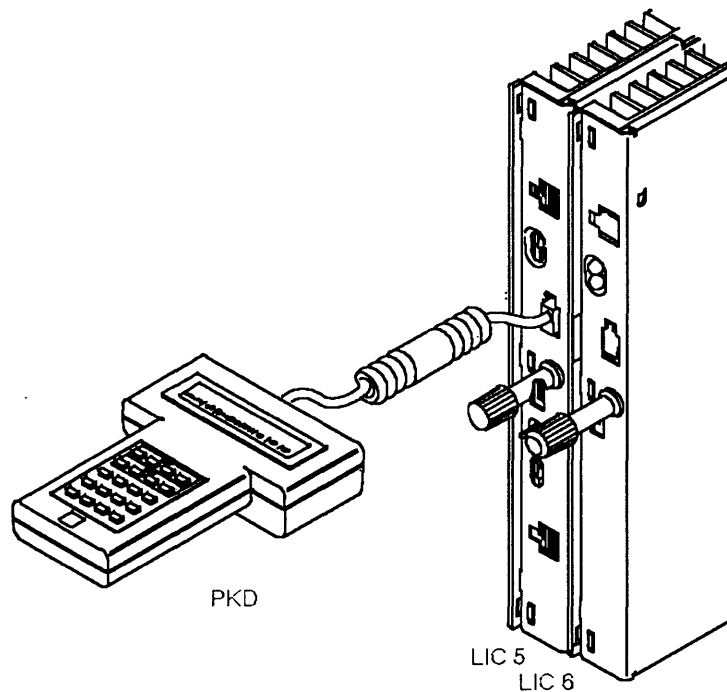
Figure 9-3. IBM 5869 Portable Keypad Display (PKD) plugged to a LIC5 or a LIC6.

Various messages can be displayed on the PKD before performing the LIC line analysis procedure (LLAP). These are described under "LIC Messages (LIC5)" on page 9-42.

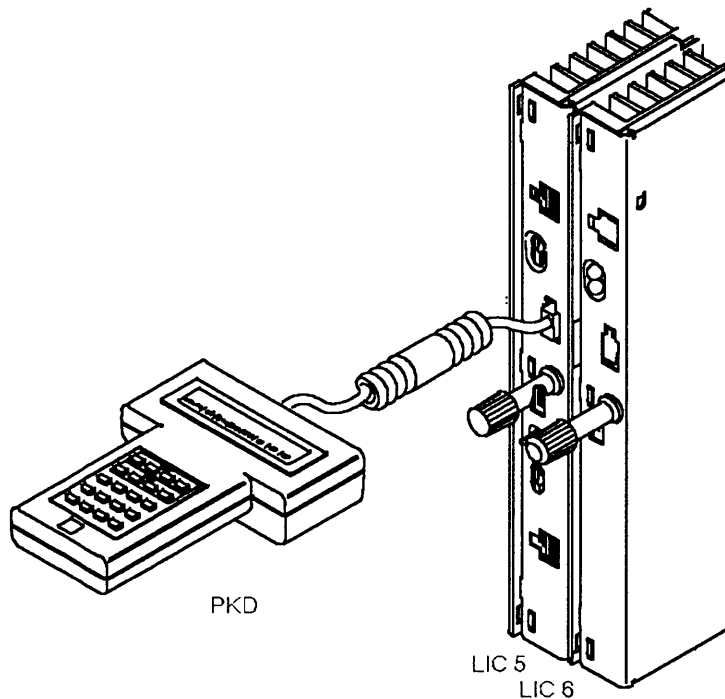
Figure 9-4. IBM 5869 Portable Keypad Display (PKD) plugged to a LIC5 or a LIC6.

8 Locate the LIC to be tested and plug in the IBM 5869 Portable Keypad Display (PKD) as described in the *3745 Connection and Integration Guide*.

- To check the lights, plug the PKD in (refer to Figure 9-4 on page 9-48 for connection); press the **Go** or **Stop** key; then the green and yellow lights should be on.

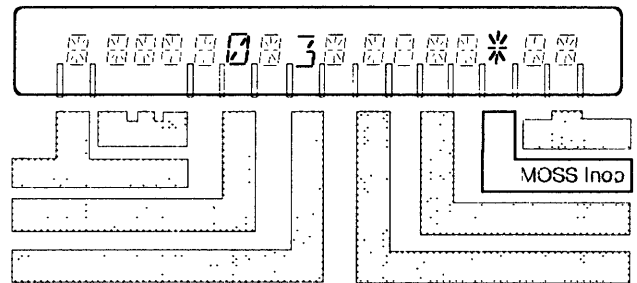
1 Note the hex code on the control panel, if:

- **000** or **blank**, go to the next step.
- Not **000** or **blank**, perform action required for that code. (See Chapter 3, "Hexadecimal Codes on the Control Panel.")

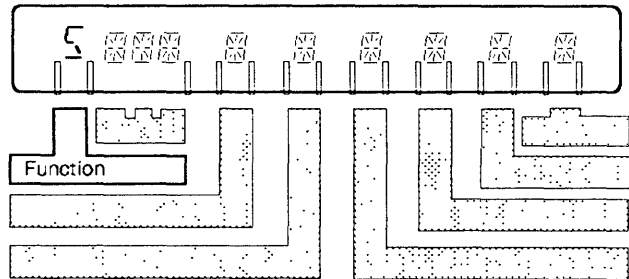
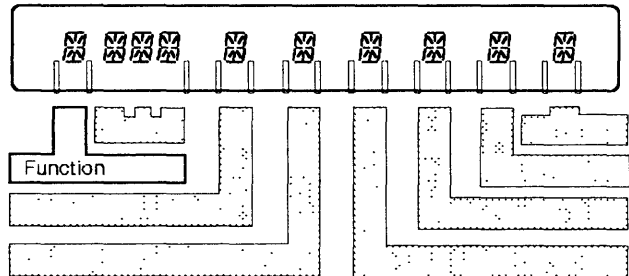
All segments of all the displays and indicators of the control panel should be lit, as illustrated.

- If all segments are lit, go to next step.
- If at least one segment is not lit, press **Exit** and

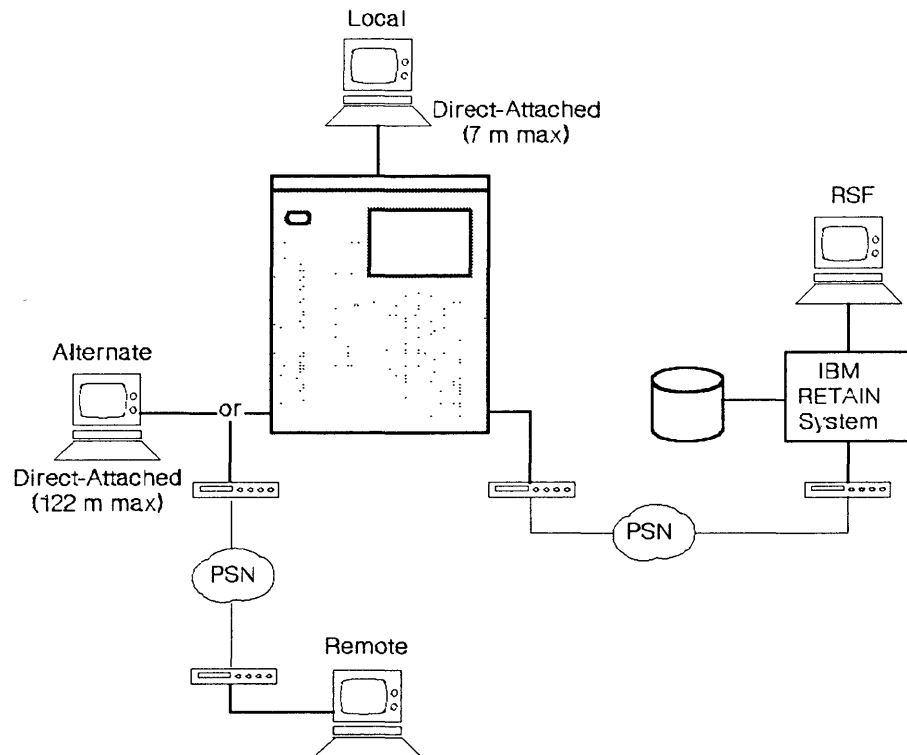
Figure 17-1. IBM 3745 with its Four Different Types of Consoles

- Local console
- Alternate console
- Local modem (at the 3745 end) for a remote console
- Local modem (at the 3745 end) for an RSF connection.

The console link test can be run without stopping your applications. Only one console can be active at a time.

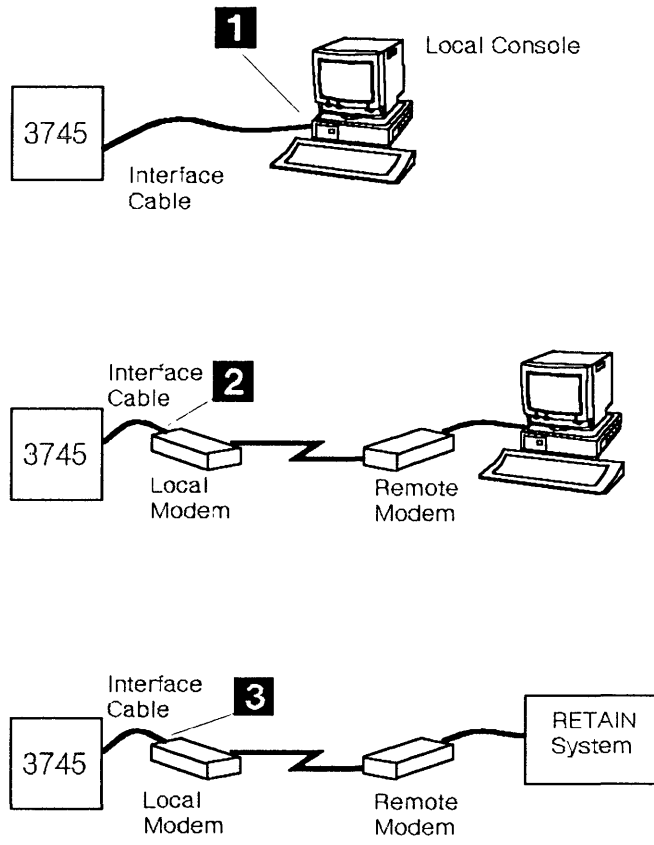
Figure 17-2. Local, Remote, and RSF Console Links

4 For the local or alternate console: Disconnect the cable **1** from the local or alternate console.

For the remote console or the RSF connection: Disconnect the cable **2** or **3** from the local modem at the 3745 end.

5 Plug the wrap plug into the end of the disconnected cable.

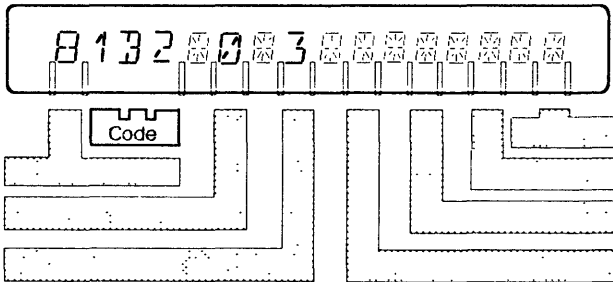
Hex Display Codes are 1B2, 1B4, or 1B6

There is no problem on the console link. Wait approximately 2 minutes to ensure that there is no transient problem.

- 1B2 = no problem on local console link
- 1B4 = no problem on remote or alternate console link
- 1B6 = no problem on RSF console link.

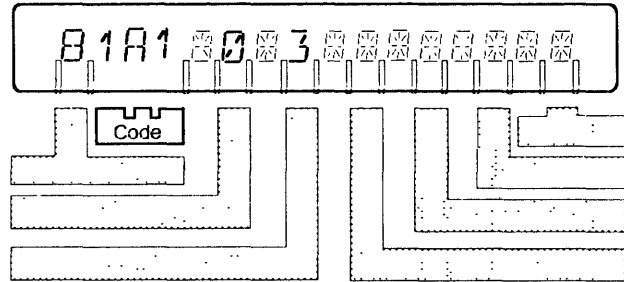
Hex Display Codes are 1A1, 1A4, or 1A7

There is a problem on the console link being tested. Follow the procedure below.

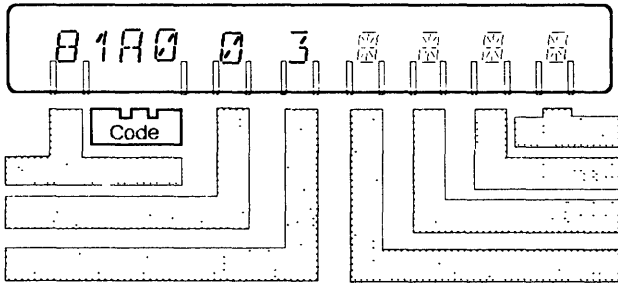
Hex Display Codes are 1A0, 1A3, or 1A6

- 1** **1A0** = Problem on local console cable or cable connector.
1A3 = Problem on remote or alternate console cable or cable connector.
1A6 = Problem on RSF console cable or cable connector.

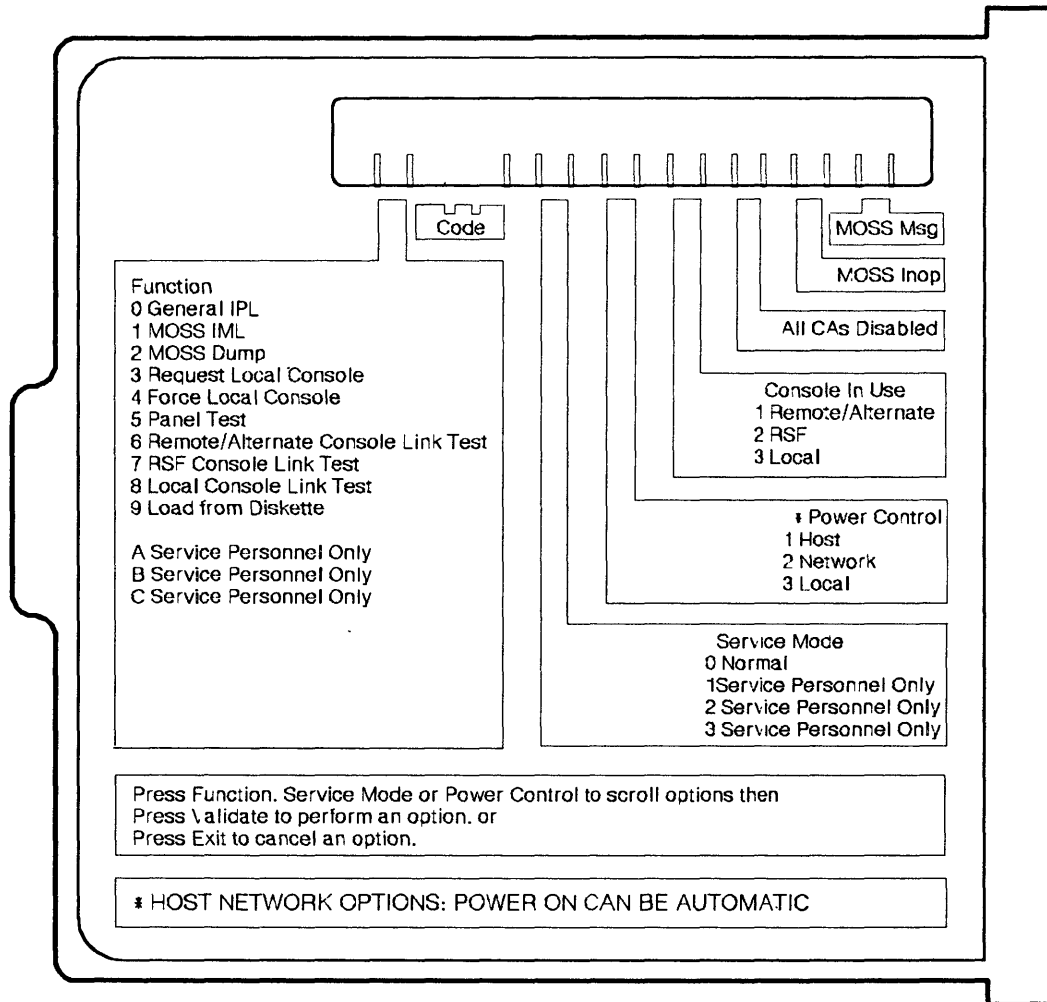
Figure B-1. IBM 3745 Control Panel Reference Card

The following control panel reference card (PN 65X8930) is attached to the diskette housing of the 3745 front panel and can be slid out for reading.

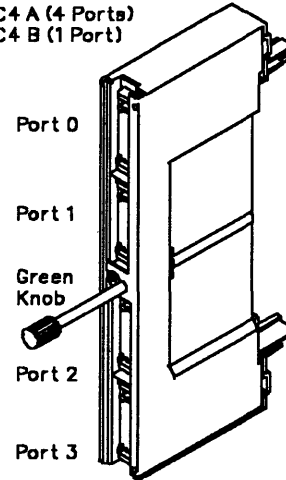
LIC4 A (4 Ports)
LIC4 B (1 Port)

- Use upper port for DCE attachment.
- Use lower port for direct attachment.
- LICs 4A and 4B are physically identical, the choice being made at configuration time.
- LIC 4B uses port 0 only.

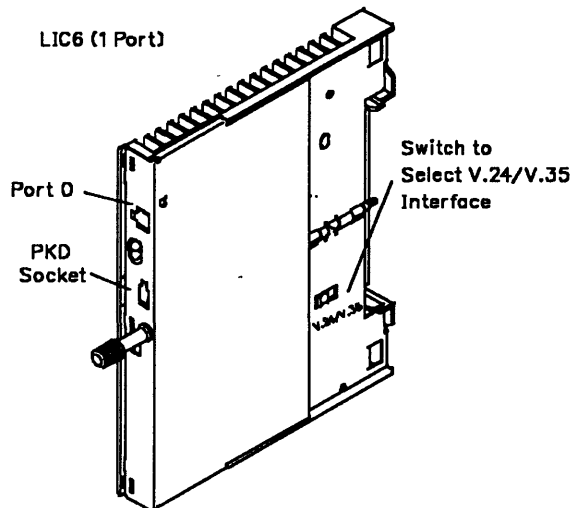
LIC6 (1 Port)

Figure C-1. LIC Types

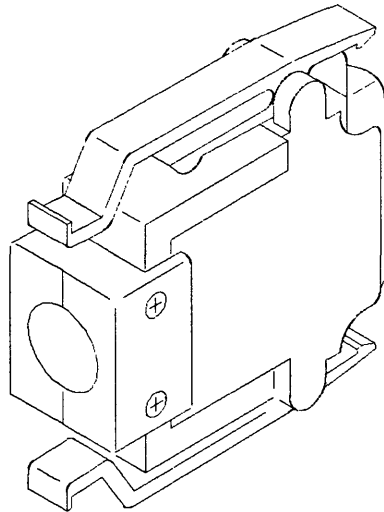
Figure C-2. LIC Type 1 and 4 Wrap Plug (P/N 65X8927)

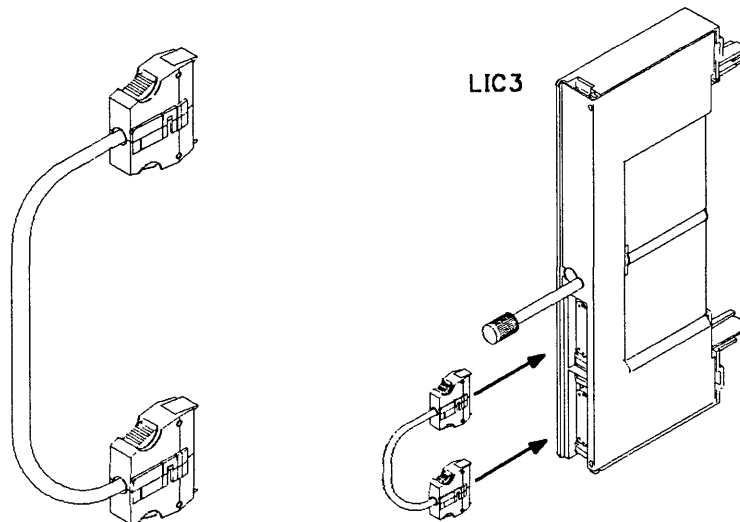
Figure C-3. LIC Type 3 Wrap Cable (P/N 65X8928)

Note: In order to test a LIC3 card, it is necessary to reverse the LIC3 wrap cable after the first test pass, then run the test again.

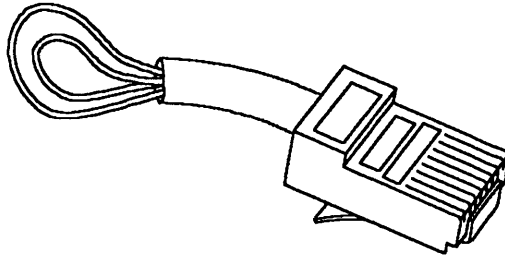
Figure C-4. LIC Type 5 and 6 Tail Gate Wrap Plug (P/N 11F4815)

Note: In addition to the tail gate wrap plug, a wrap block is also shipped with the machine. This wrap block may be plugged at the end of the cable (at the customer wall frame side) to test the line up to the customer wall frame.

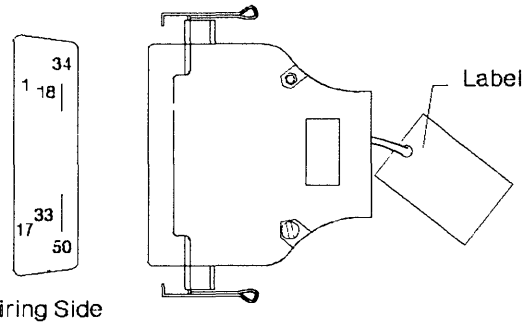
Figure C-5. HSS Lines Wrap Test Plug

HSS wrap plug for V.35 lines, P/N 58X9349

HSS wrap plug for X.21 lines, P/N 58X9354

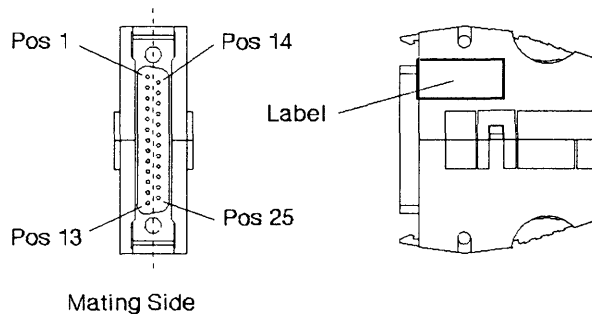
Figure C-6. Console Wrap Plug

Wrap plug for the 31xx console, P/N 6398697
